INTERVENTIONS ON ANCIENT BUILDINGS STRUCTURE

Francisco Jurado Jiménez, Architect, Polytechnic University of Madrid
e-mail: francisco.jurado@upm.es

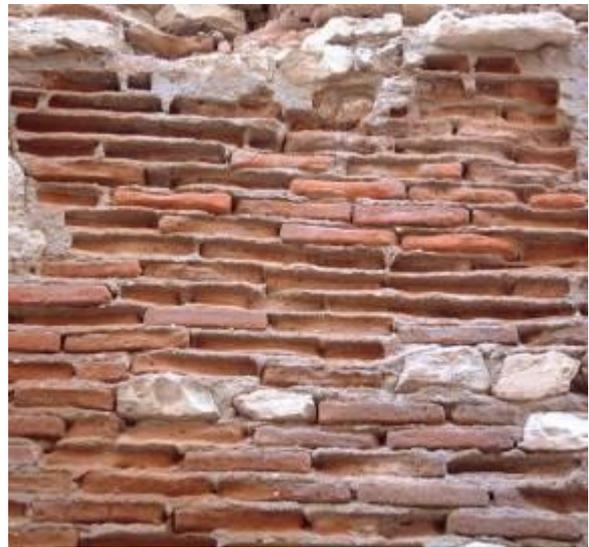
The pictures above show the effect of filling with stiffer more waterproof cement mortar on a traditional brick masonry affected by water flow from the retained back soil: the brick becomes the “sacrificed” material, instead of the mortar.

In the course of time, brick turns into sand and disappears, whereas a “soft” restoration would have refilled again with lime mortar. It is more desirable a slow damage on this material than the disappearance of the main one.

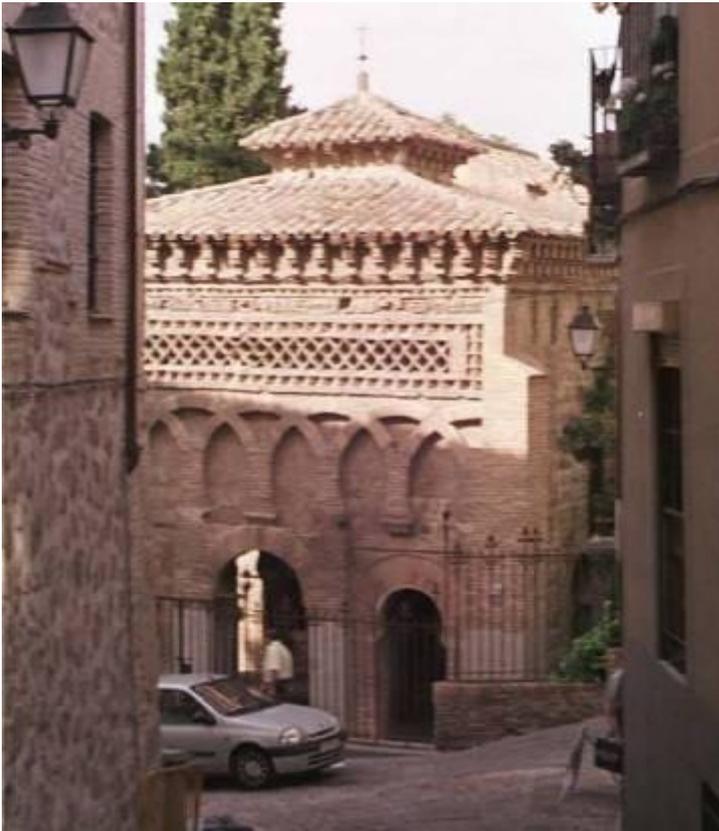
Bab al Mardum Mosque (Cristo de la Luz), Toledo

It is an example of a more than ten centuries old ductile structure.

Besides the surprising use of plaster mortar mixed with wood shavings to gain elasticity for its masonry; after an intervention with archaeological methods, we discovered the original roof system: a filling of clay with lime among and over the vaults forms the external shape of a single dome with a central lantern.

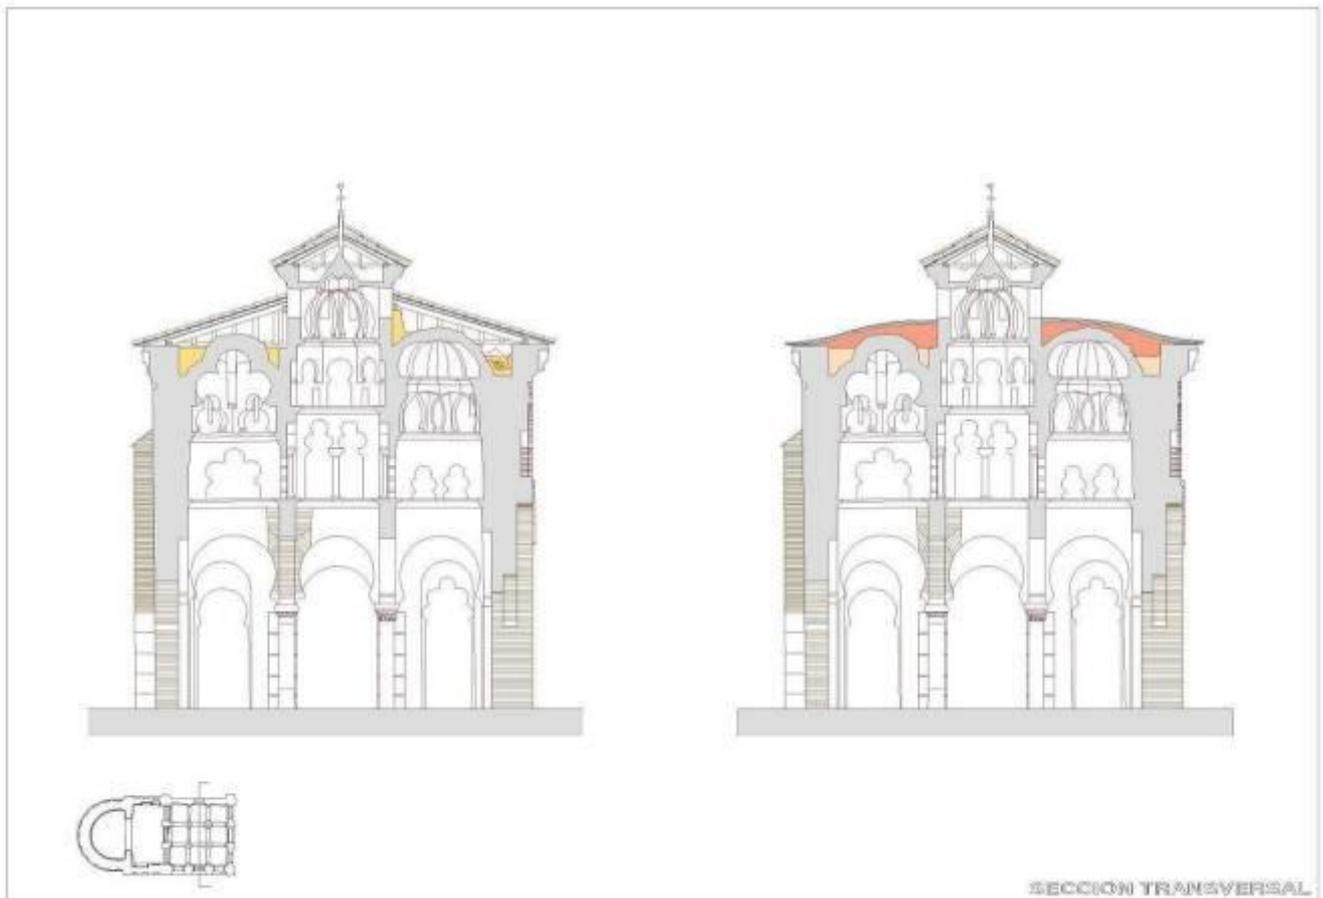
We can see below the main cross-section of the building before the restoration, with a wood roof structure that obstructed the lantern; and the recovery of the original system after the restoration.

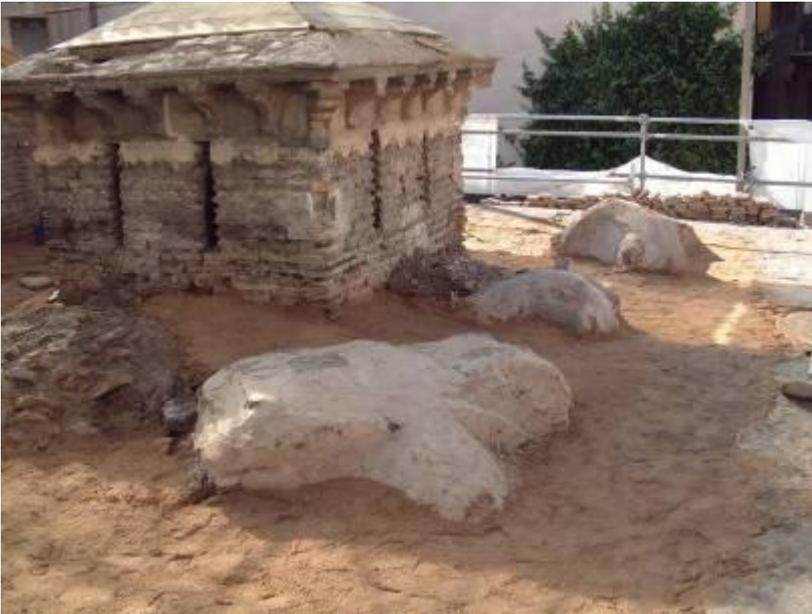
Repair of broken vaults with plaster, and filling of clay and lime to recover the original outline of the roof.

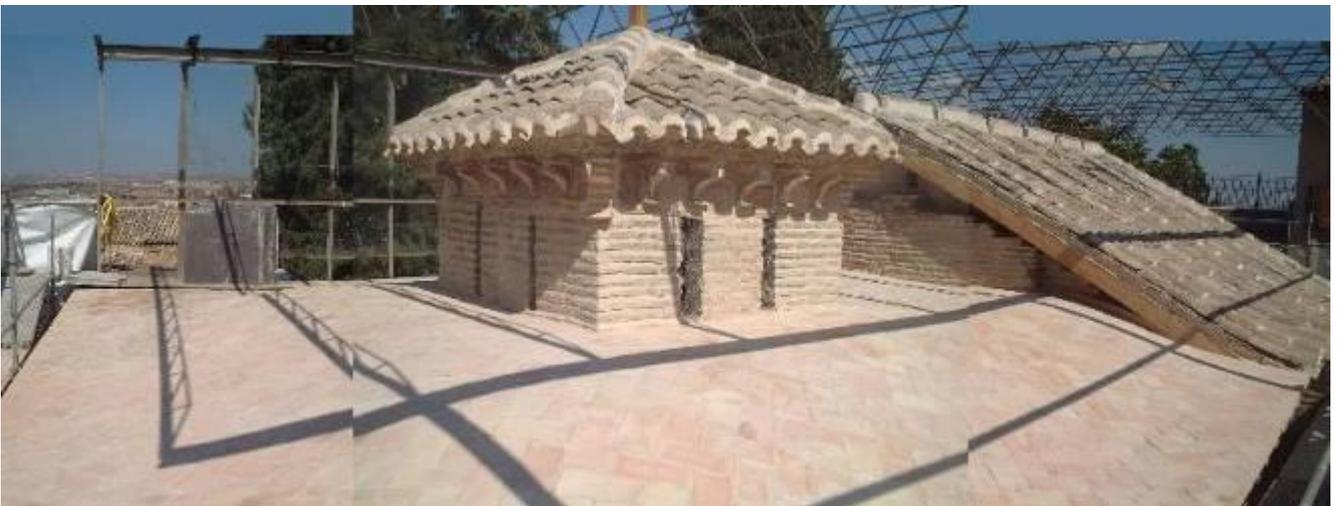
Above, just finished roof with restored central lantern. Below, the drawing shows the Christian extension: the mudejar apse attached to the mosque two centuries after its building.

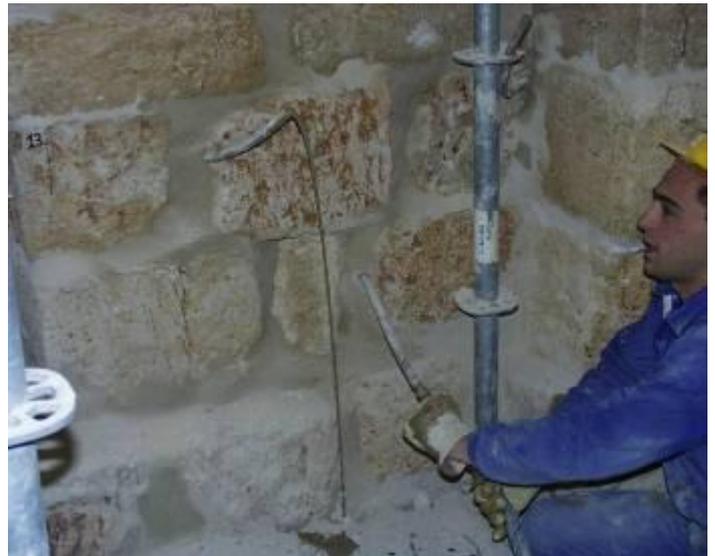
After refilling external ashlar, we injected hydraulic lime to fulfill and join together the masonry core, up to 5% of walls total volume.

At the same time as lime reached disintegrated areas, monitorized deformations got less and less significant up to complete stability, as graphics below shows.

The tower showed serious cracks, and was fast becoming ruins. The process was monitorized, and we could see an internal disintegration of masonry.

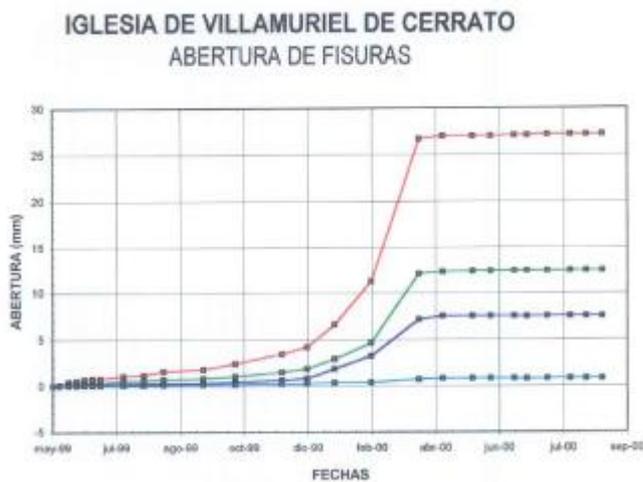
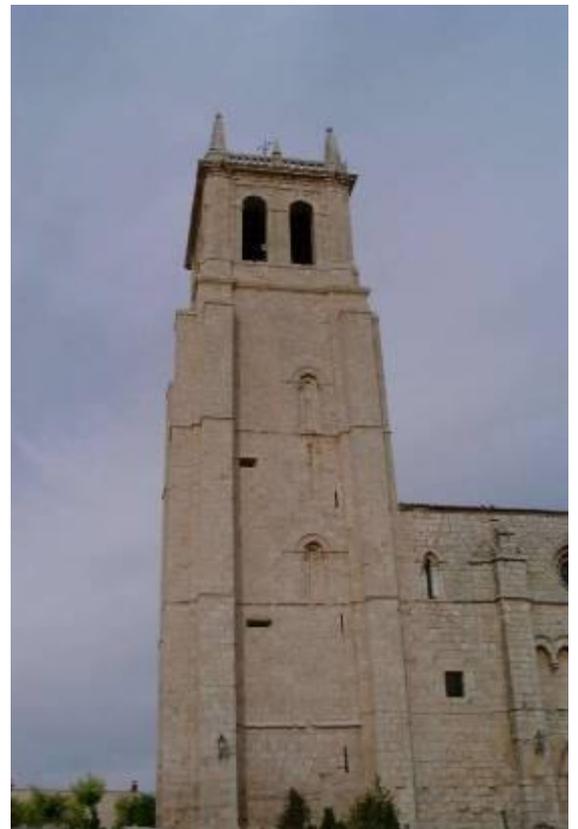
The picture on the right shows the appearance of the tower after its restoration.

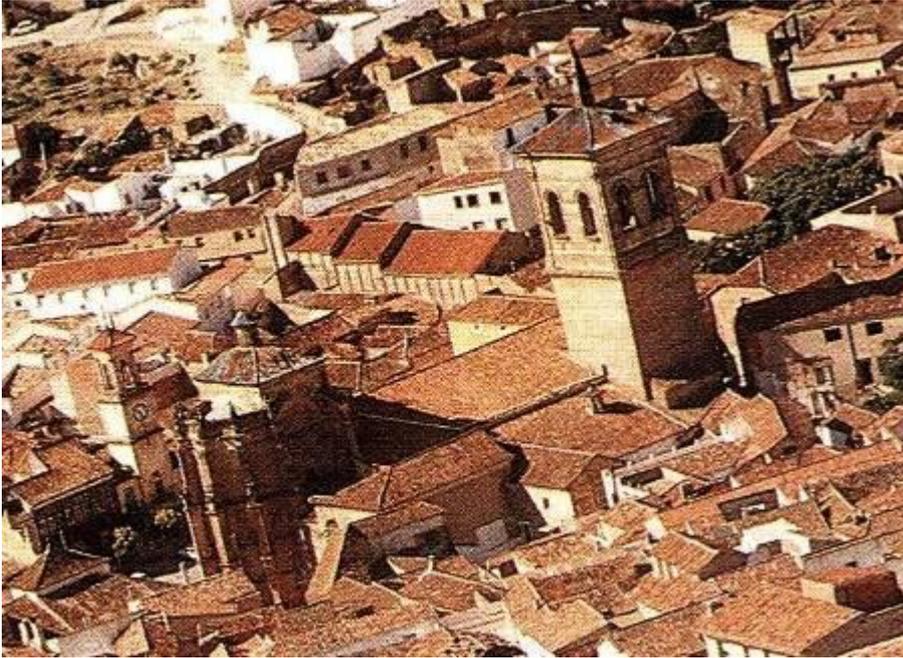
Sta. María del Salvador Church in Chinchilla (Albacete)

At this magnificent church, gothic, renaissance and baroque styles are merged.

The most important element of this church is the apse, where an unfinished renaissance extension for the former gothic church just begun.

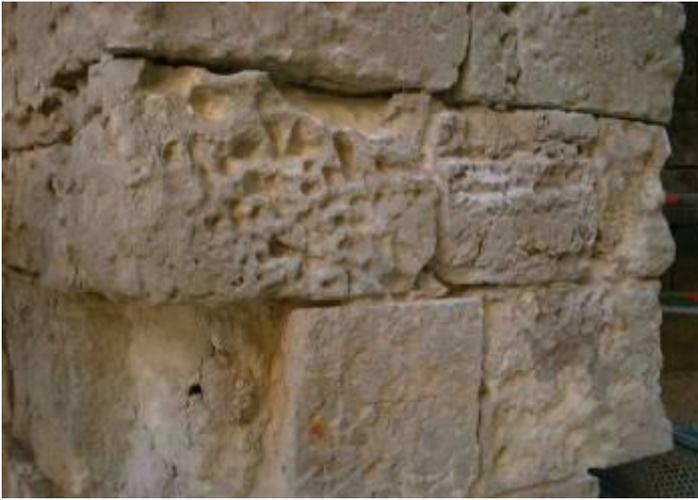
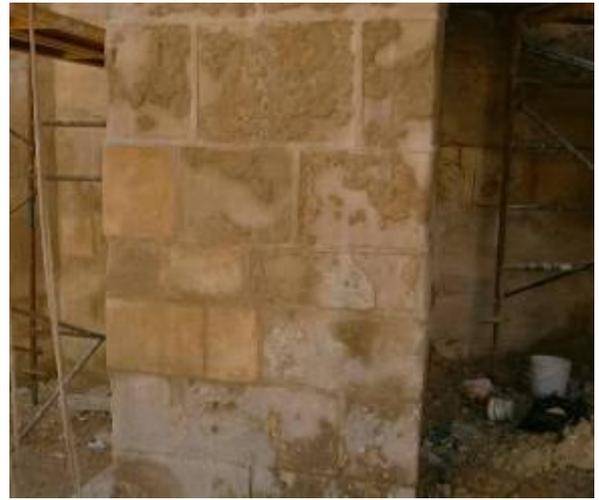
Such a “classic” material in ancient buildings as lime mortar, is perfect to make “tooth-like” fillings in damaged and eroded ashlars, at a slightly lower level than the surface.
This solution is always more desirable, as it preserves the whole original wall, and keeps a visible difference between old and new; than cladding with new stone, cutting out the original masonry, so that it looks unnaturally renovated.

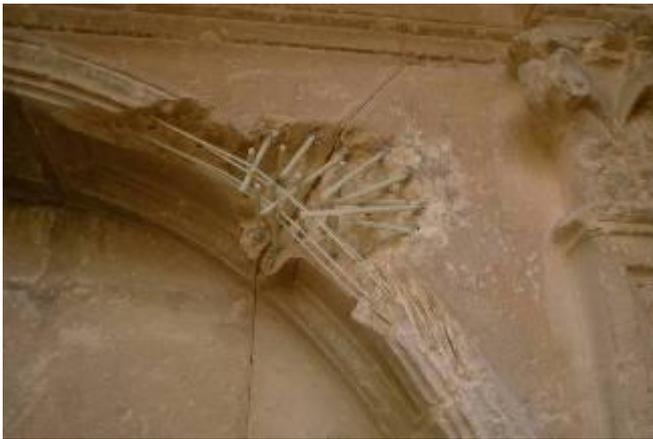
We can even use lime mortar, with an internal glass fiber frame, to rebuild disappeared volumes and decorative elements.

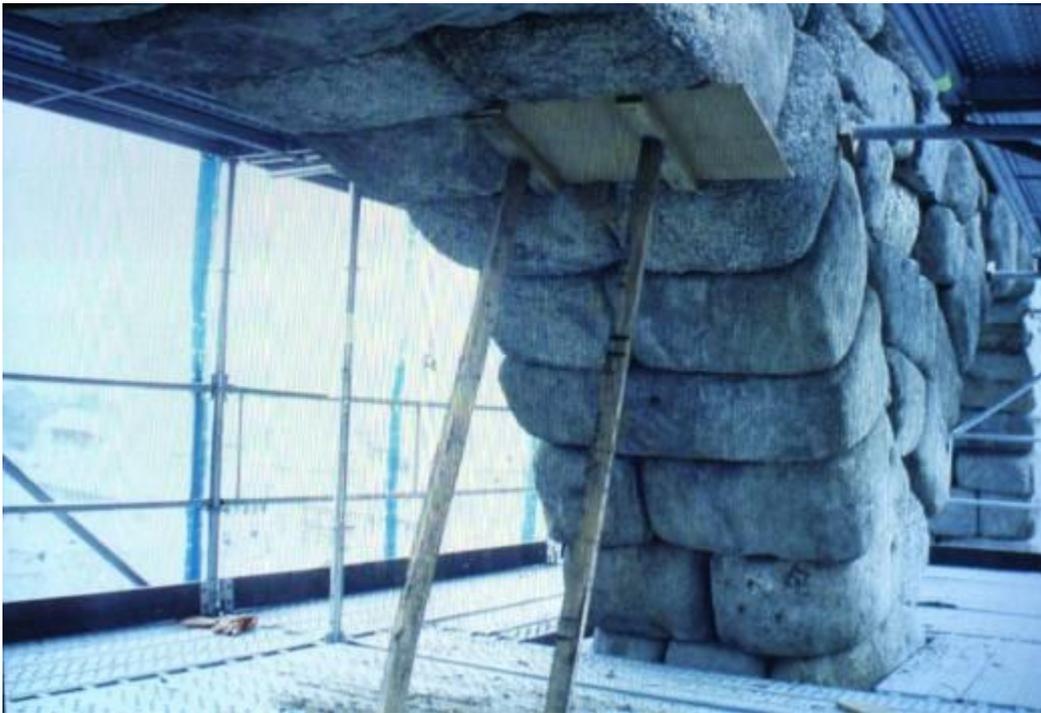
Roman aqueduct, Segovia

Instead of substituting ashlars, which involves dismantling arches and pillars structures, we made localized completions with artificial stone (cement mortar is even less resistant than the old aqueduct granite), keeping every ashlar independence, and not joining it with adjacent ones.

This solution is “passive”, it does not imply any change in load routes (the picture above shows a shuttering, not a prop), nor the contrary, as new material begins to work only little by little, when the structure needs it.

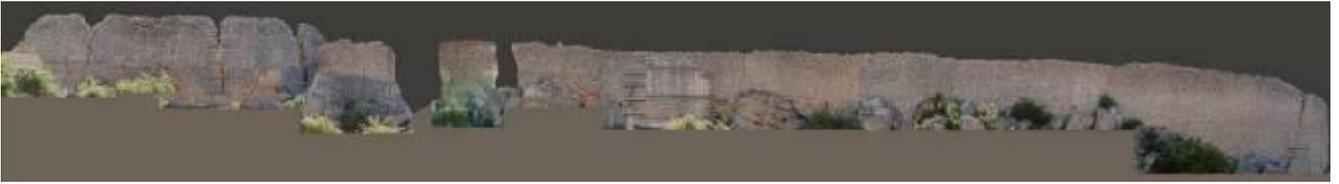
Atienza Walls (Guadalajara)

These huge sections are built with two external stone masonry sheets of little ashlars, and internal cyclopean (with great rocks) concrete filling.

Lime concrete is similar to the original material, and useful to restore cracks and disappeared sectors.

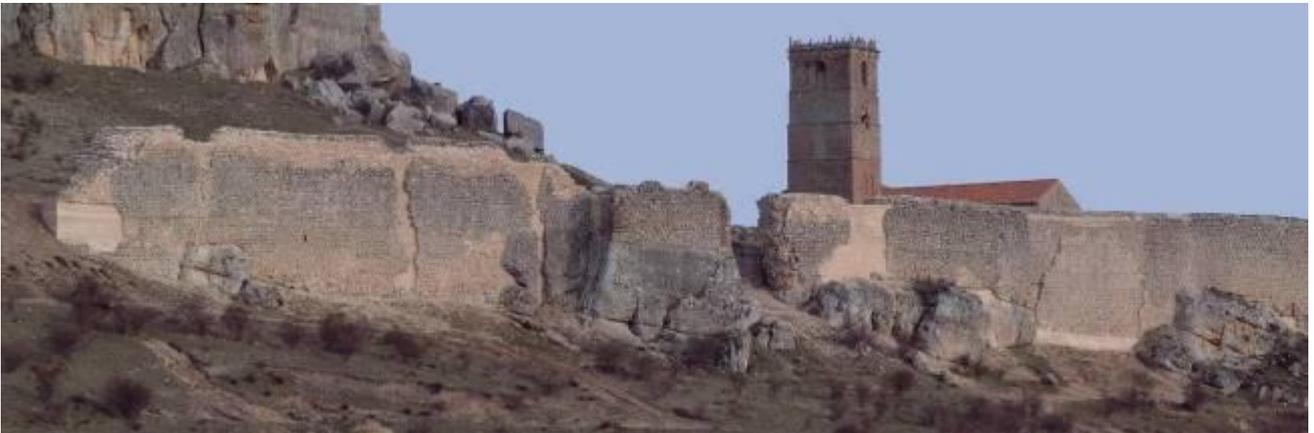
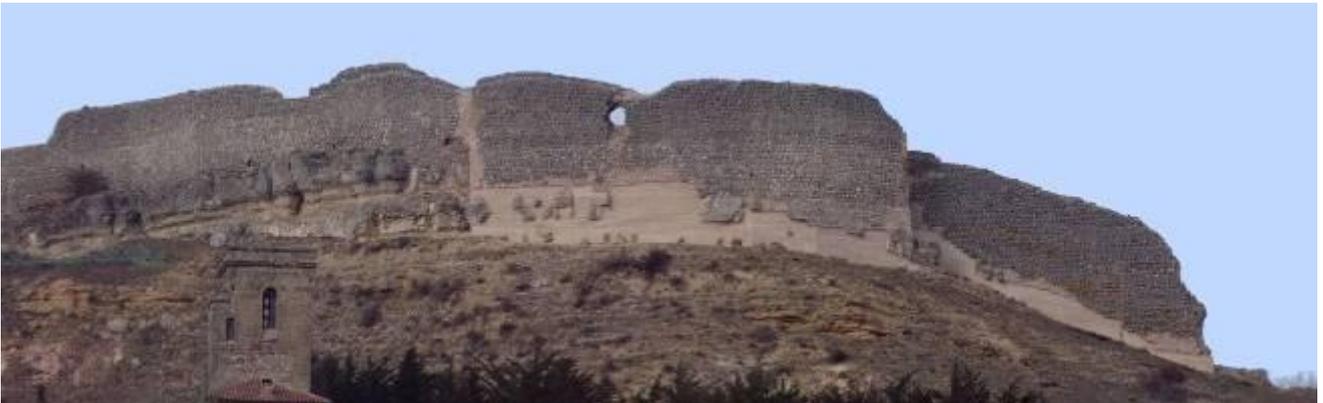
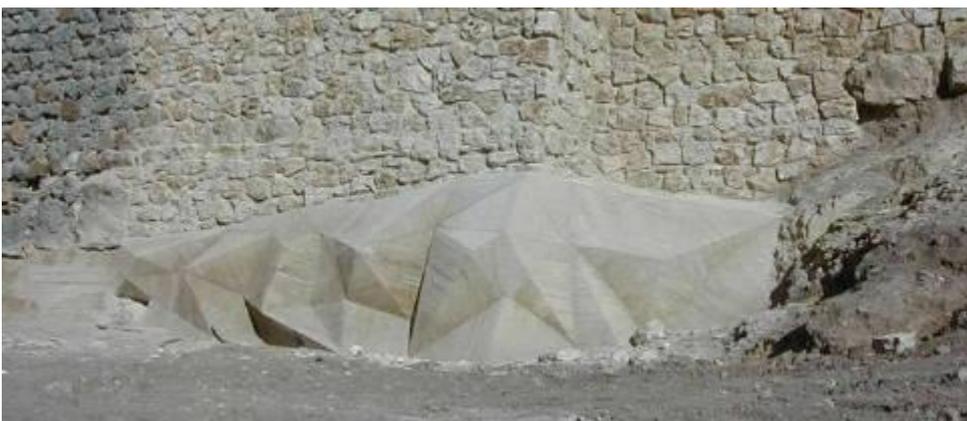
We were specially careful with external texture, in order to make it as variable as the original with changing sunlight angle.

We used narrow plank shuttering, cut out against the original wall's remains, leaving current sections at a slightly lower level than remaining ones.

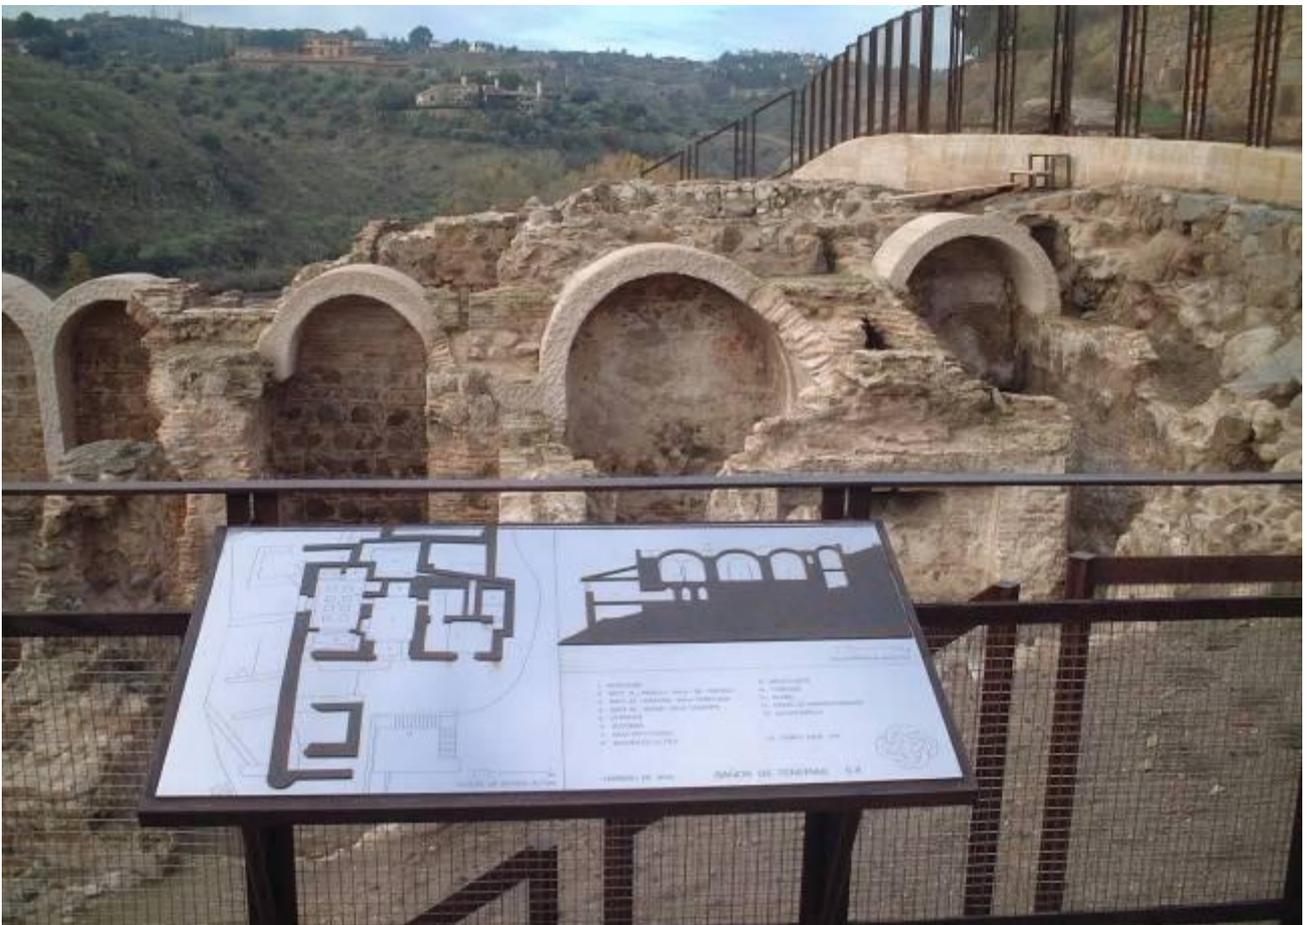
Tenerías Arab Baths in Toledo

In this case, lime concrete is used to rebuild disappeared vaults. Our method is the most conservative, as we preserve even the slightest original masonry remain to integrate it in reconstruction.

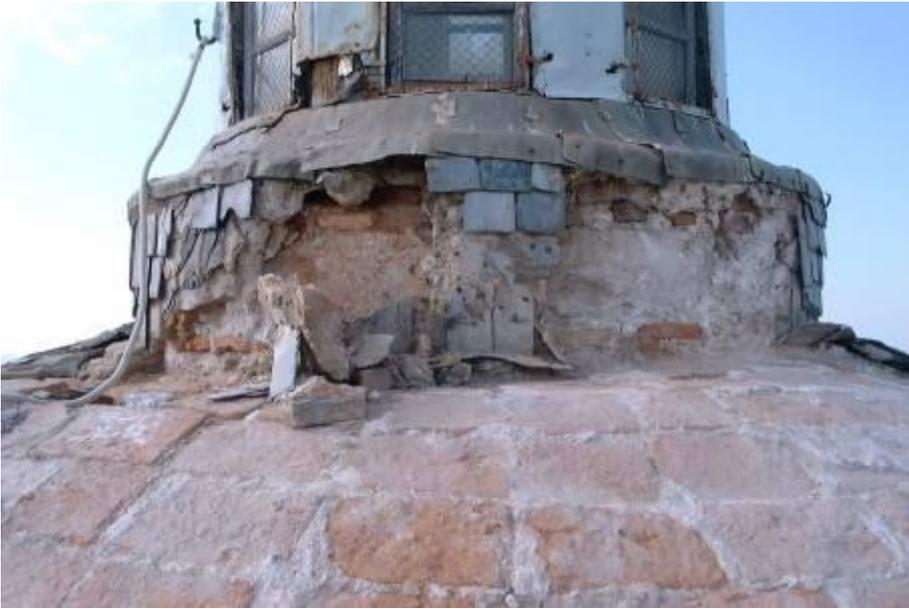
Cupola drum during restoration, when damaged masonry was uncovered.

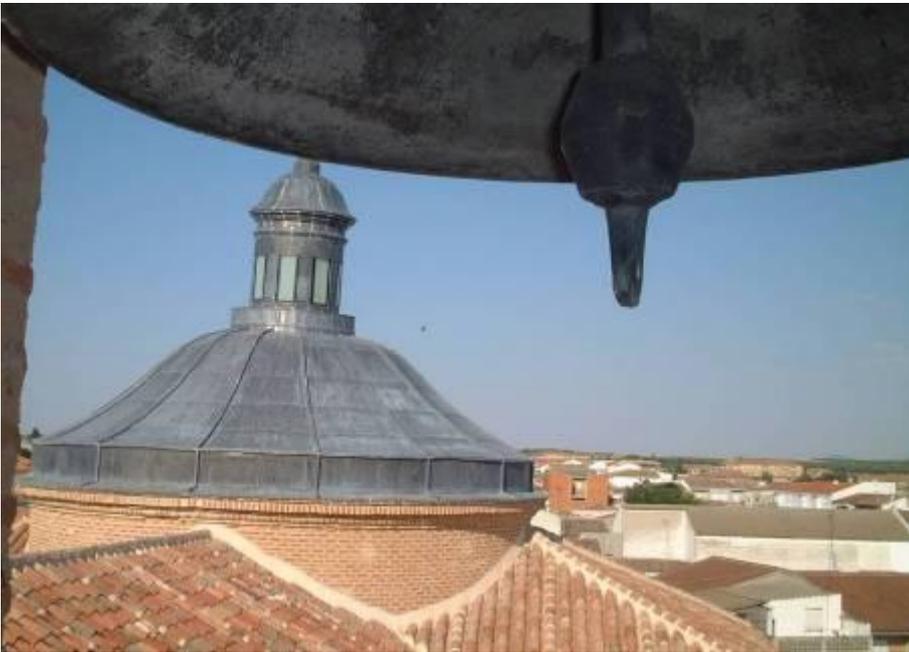
Already consolidated dome, with a new lead cover.

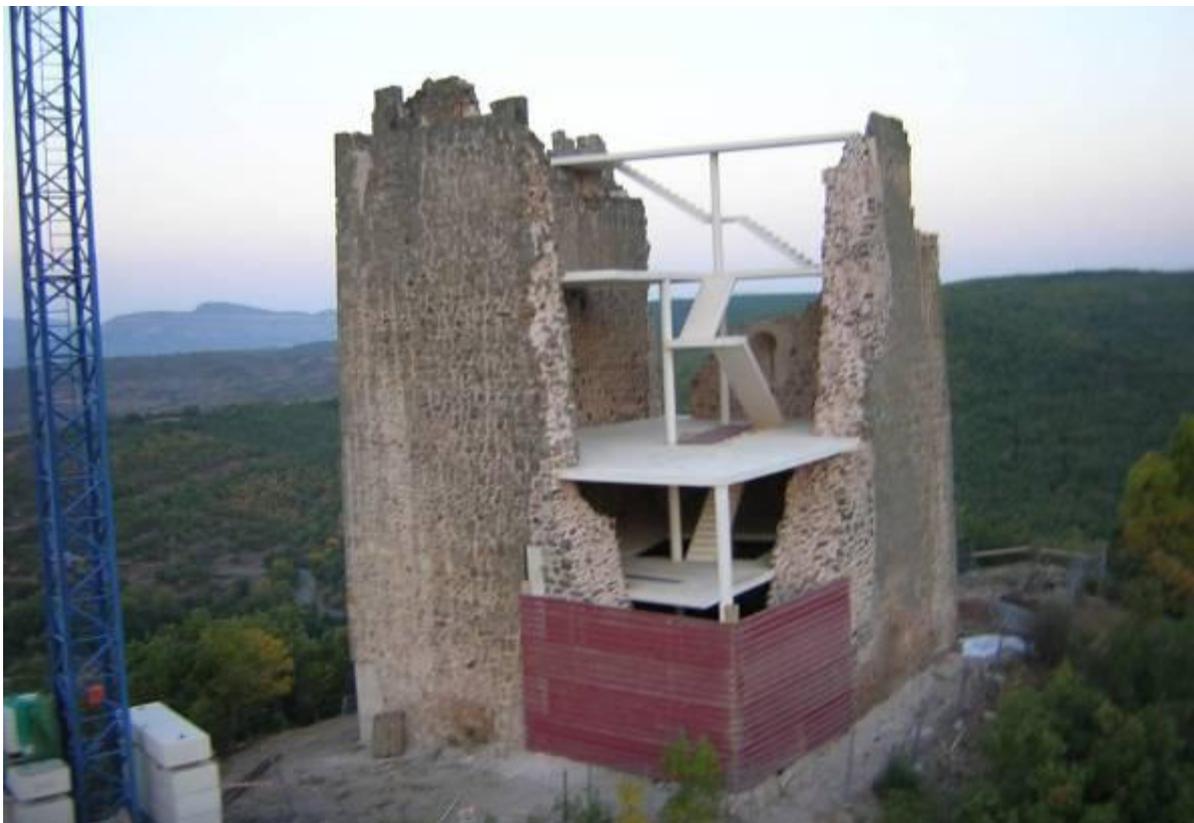
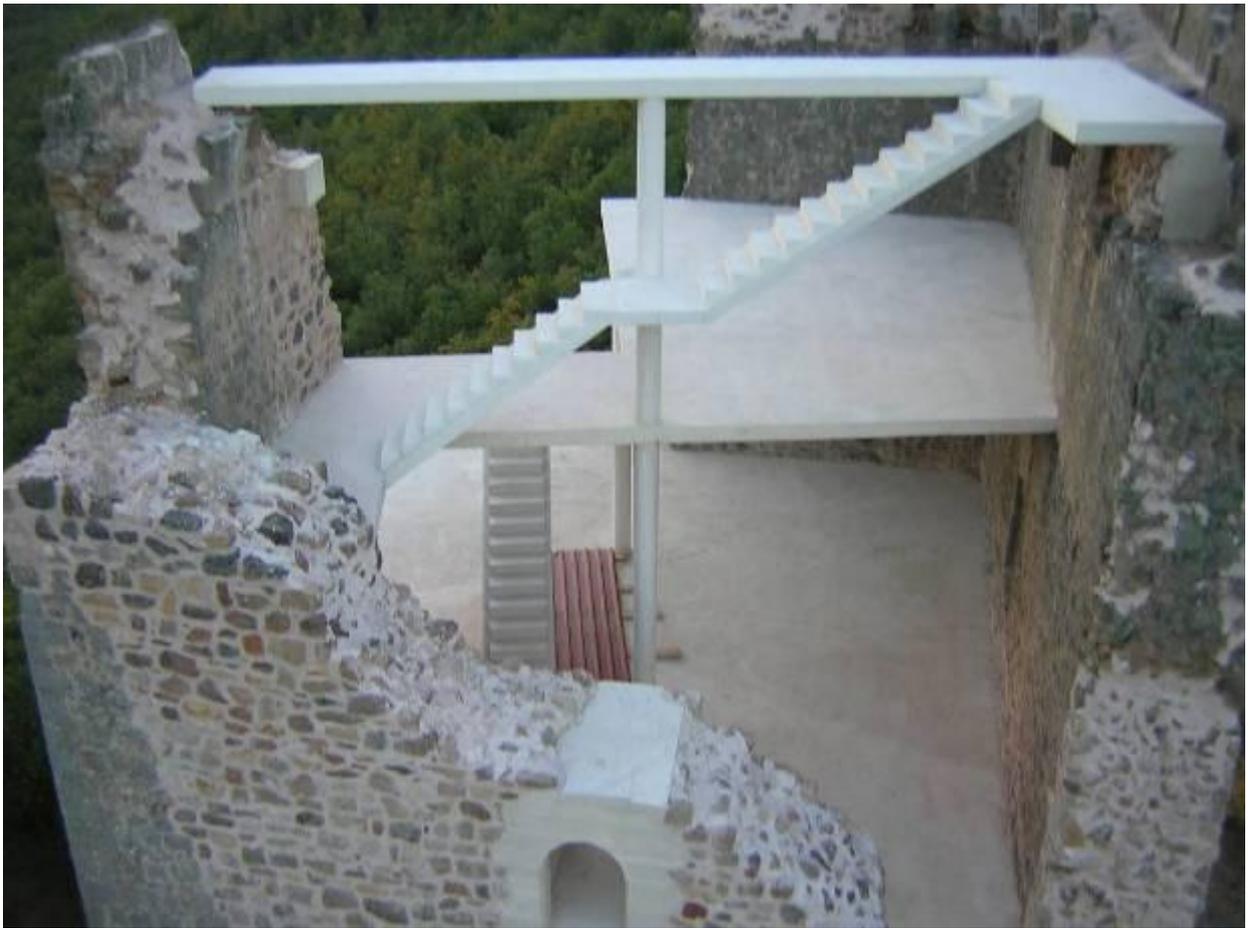
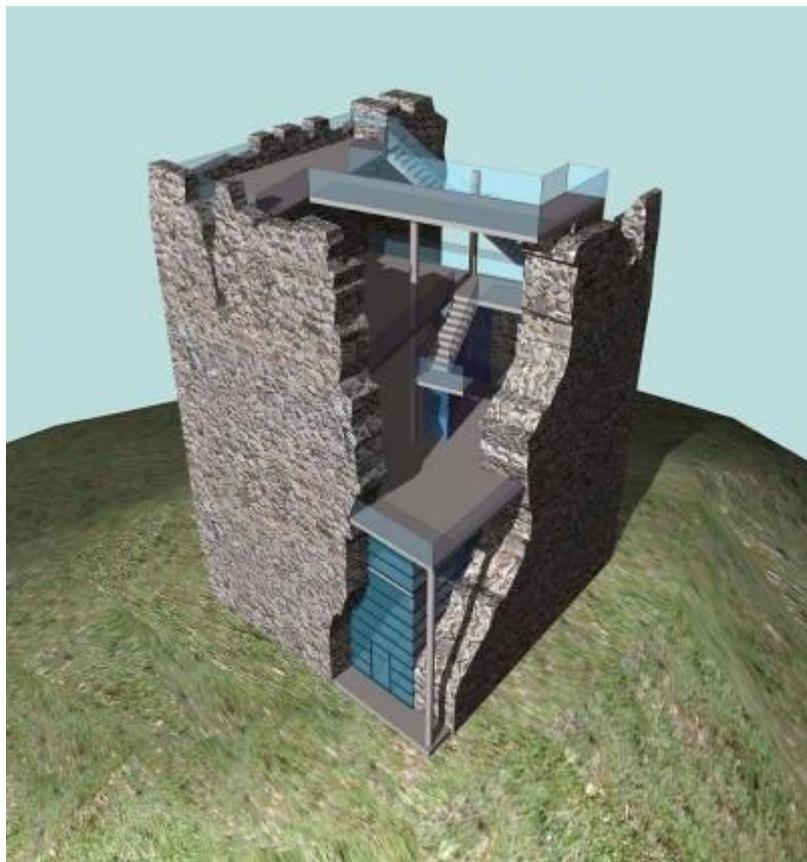
In this case, white reinforced concrete lets us build a minim structure that anchors on, leans on, and braces the powerful remains of medieval masonry, or a rebuilding of them made by anastilosis of fallen material. At the same time, this new structure recovers former levels inside the tower, making them accessible up to the battlement.

Computer model of restored tower, now used as a museum.

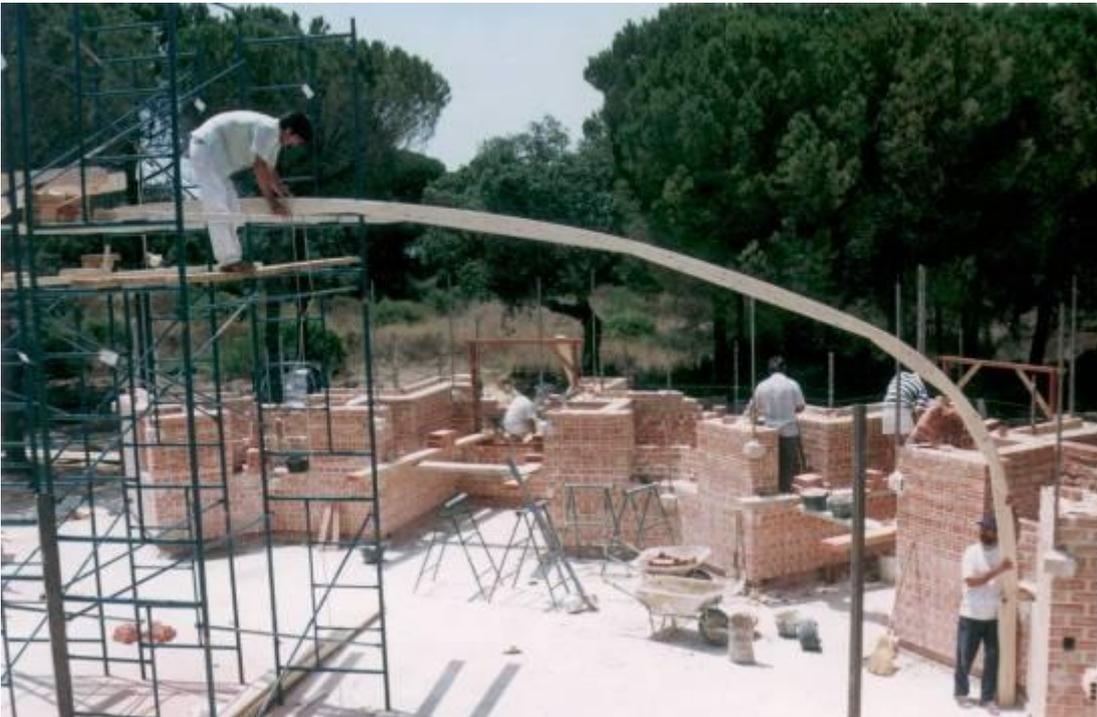
Vault in Arcos de la Frontera, Cádiz (reproduction of Carlos V Palace crypt in Alhambra, Granada)

Although the original material is stone, this brick can reproduce the traditional building system of “tabicadas” vaults (built with bricks on flat way). This one has a 14 meters span.

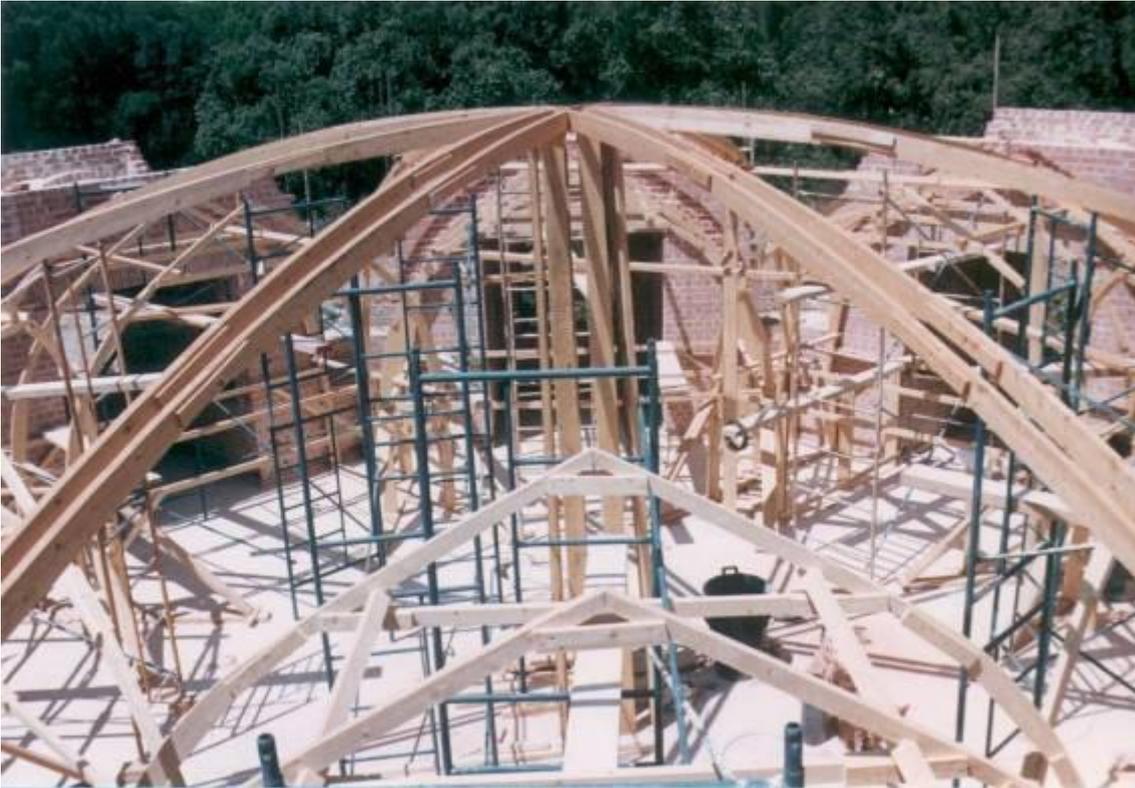
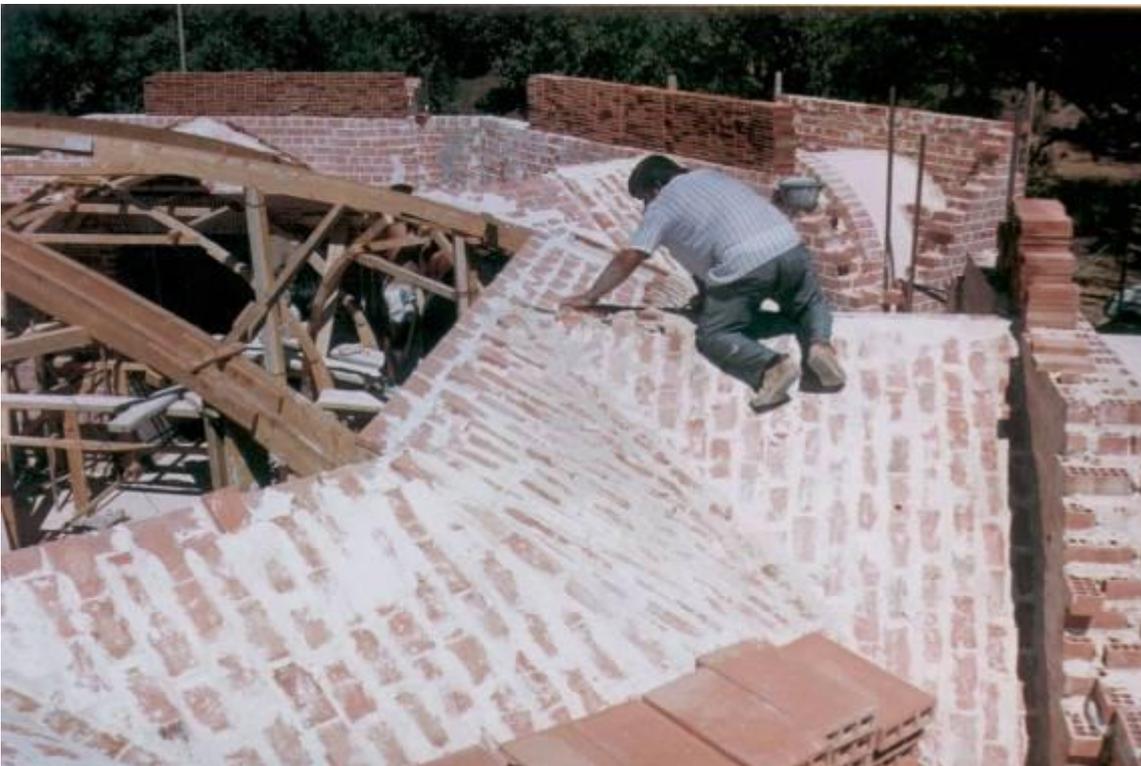
Timber elements are not exactly centering, but three-dimensional guidelines of the vault geometry. The lunette stiffness, as well as the thickness of contour walls, made up with permanent brick shuttering and internal filling of local soil, allow workers to build the first layer of brick, stuck with plaster, without props, 7 meters above the ground. Two additional crossing brick layers, this time with lime mortar, will complete the definitive thickness.

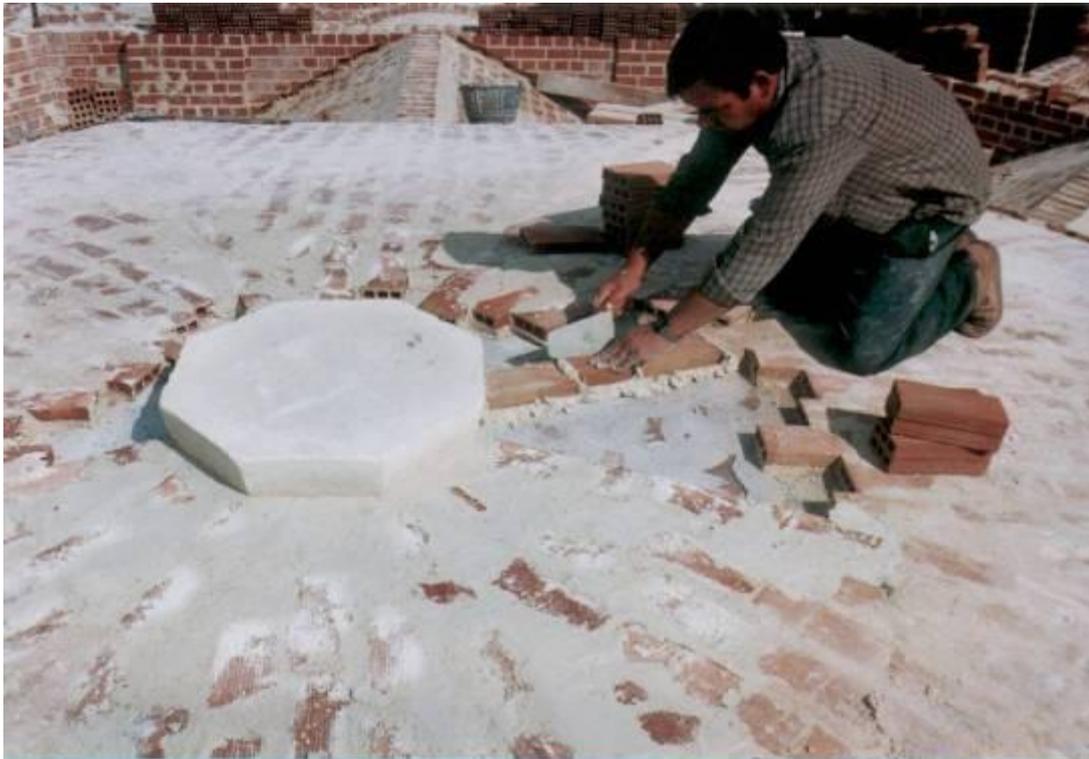
Even the vault size was determined with a graphic method: the base thickness is calculated to avoid any tensile stress. Once the vault was closed with the keystone (an octagonal piece), the workers, who had never built anything like this, trusted the stiffness of the building, even though it had not any steel at all.

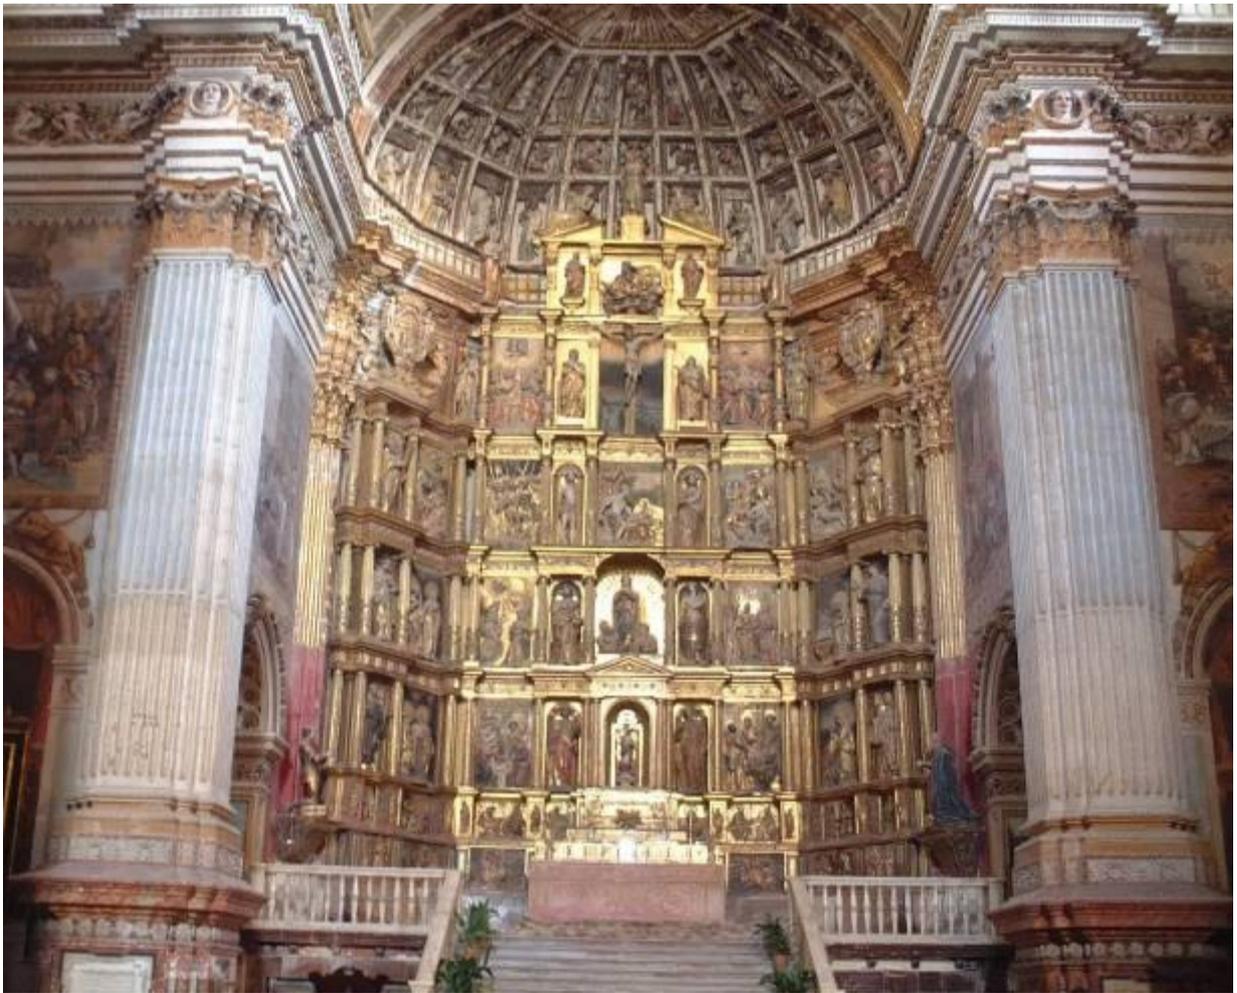
San Jerónimo de Granada Monastery. Perimetral underground “cámara bufa” (ventilation cavity).

Brick is now used to build vertical vaults to retain soil, as well as flying-buttress-like half-arches against the building foundations, to create a cavity to ventilate the damp masonry.

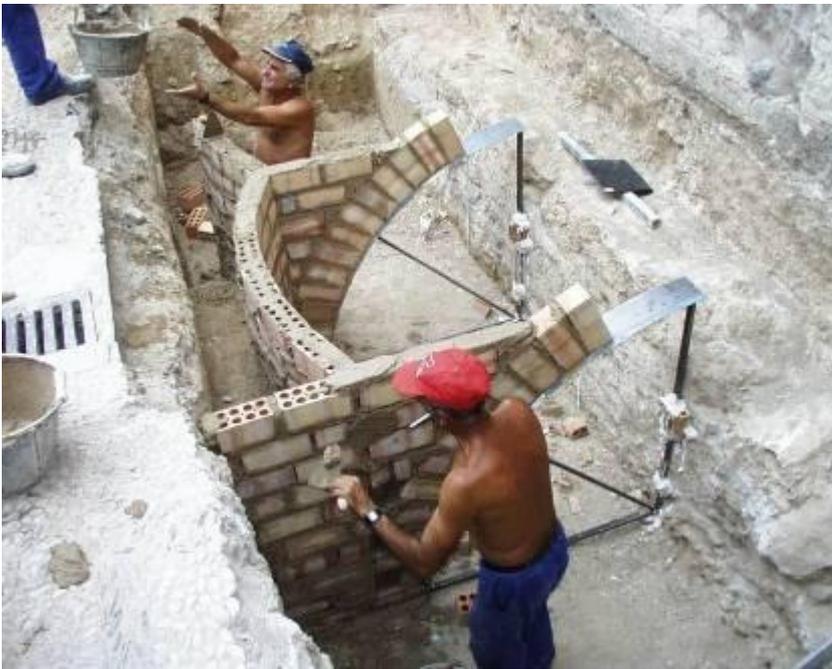
Brick is easy to handle, and allows water to flow through it, so that vertical vaults are free of water pressure on its back surface.

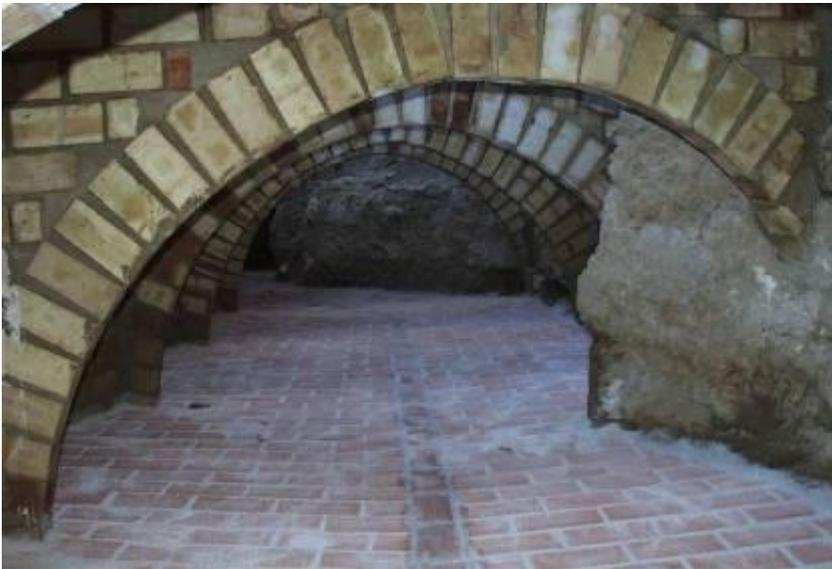
Brick can also be used to make the lower slab and the gutter to channel the water inside the cavity. It is directly leaning on the soil, without any mortar, in order to improve evaporation through it.

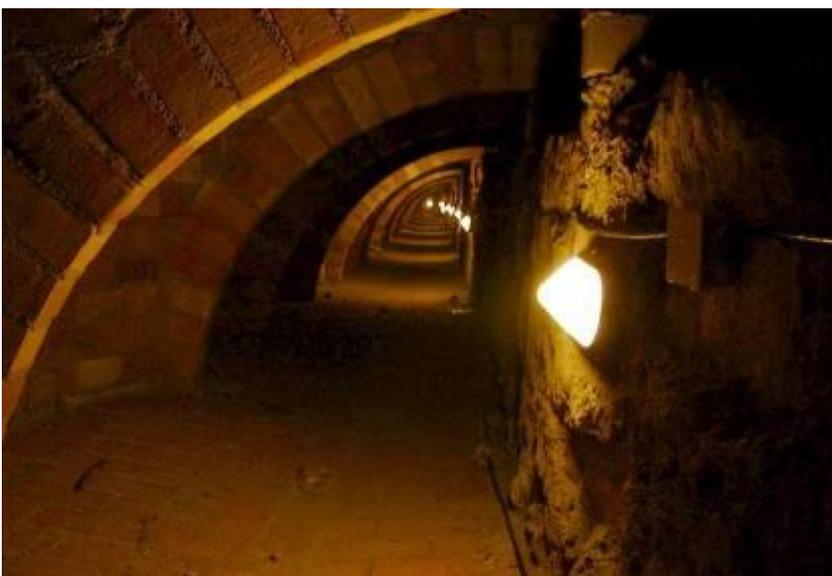
One can walk along the cavity and surround the church foundations. There are perforations open to indoor crypts, and ventilation grilles open to the street above, so that a permanent draught dries the natural dampness of soil, that before the rehabilitation used to come to the surface and condense inside the church through the marble paving.

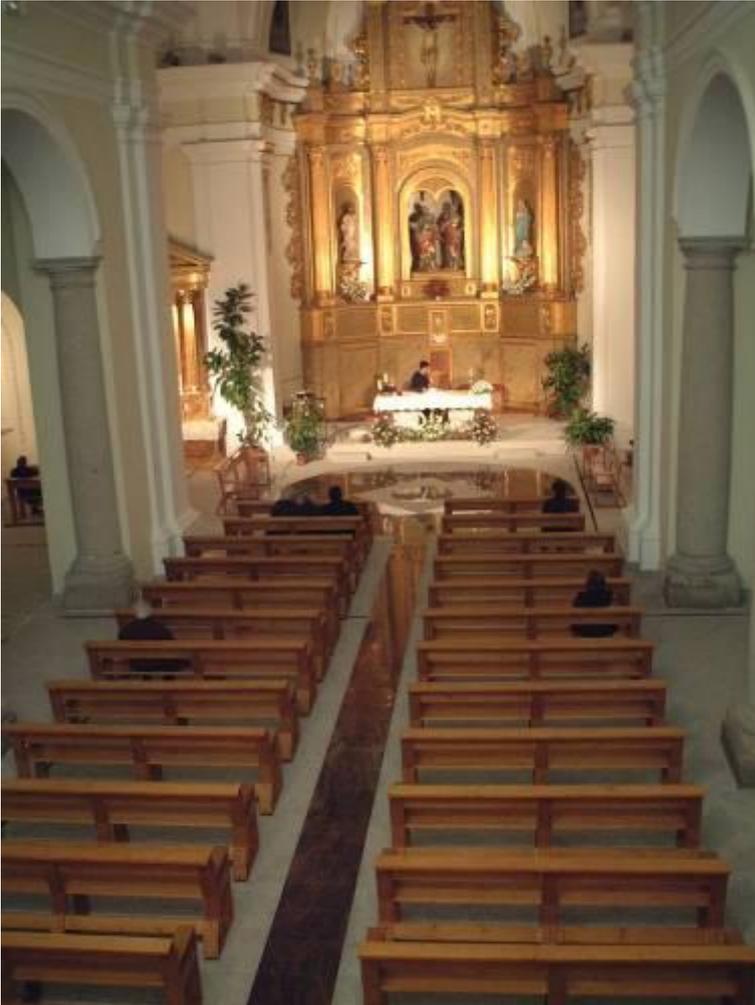
Indoor paving. Parish Church in Polán (Toledo)

The pavement we found (it was not the original one), made up with hydraulic floor tiles, was loose and damaged because of dampness, as it was leaning directly on the soil.

We designed for the indoor rehabilitation a new granite paving, leaning on a concrete slab with pipes for underfloor heating.
