INTERVENTIONS ON ANCIENT BUILDINGS STRUCTURE

Francisco Jurado Jiménez, Architect, Polytechnic University of Madrid
e-mail: francisco.jurado@upm.es

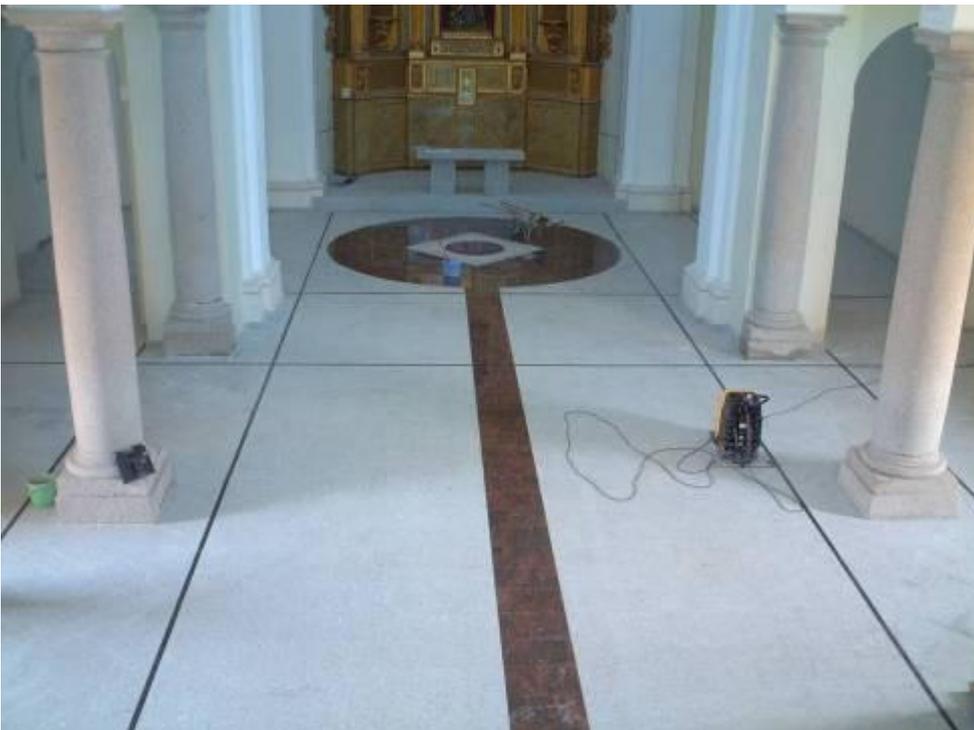
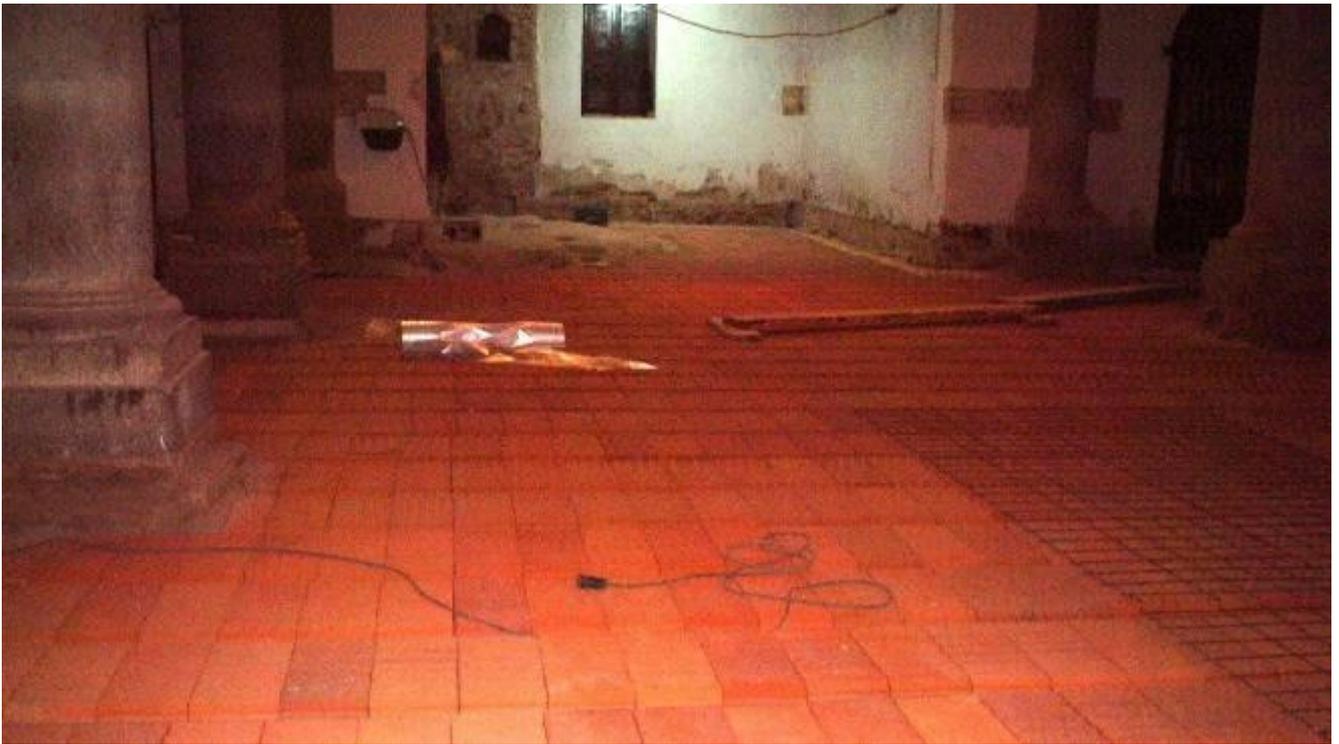
In order to allow subsoil dampness evaporation, we made a ventilated slab, with ceramic flooring blocks under the concrete.

The blocks are face down, aligned, directly leaning on the soil (in this case soil with superficial graves and tombs), and open to two opposite facades, with different sun heating, to get passive ventilation. On the blocks, we place a plastic sheet, and next, the steel rods to reinforce the slab, the heating, and the pavement.

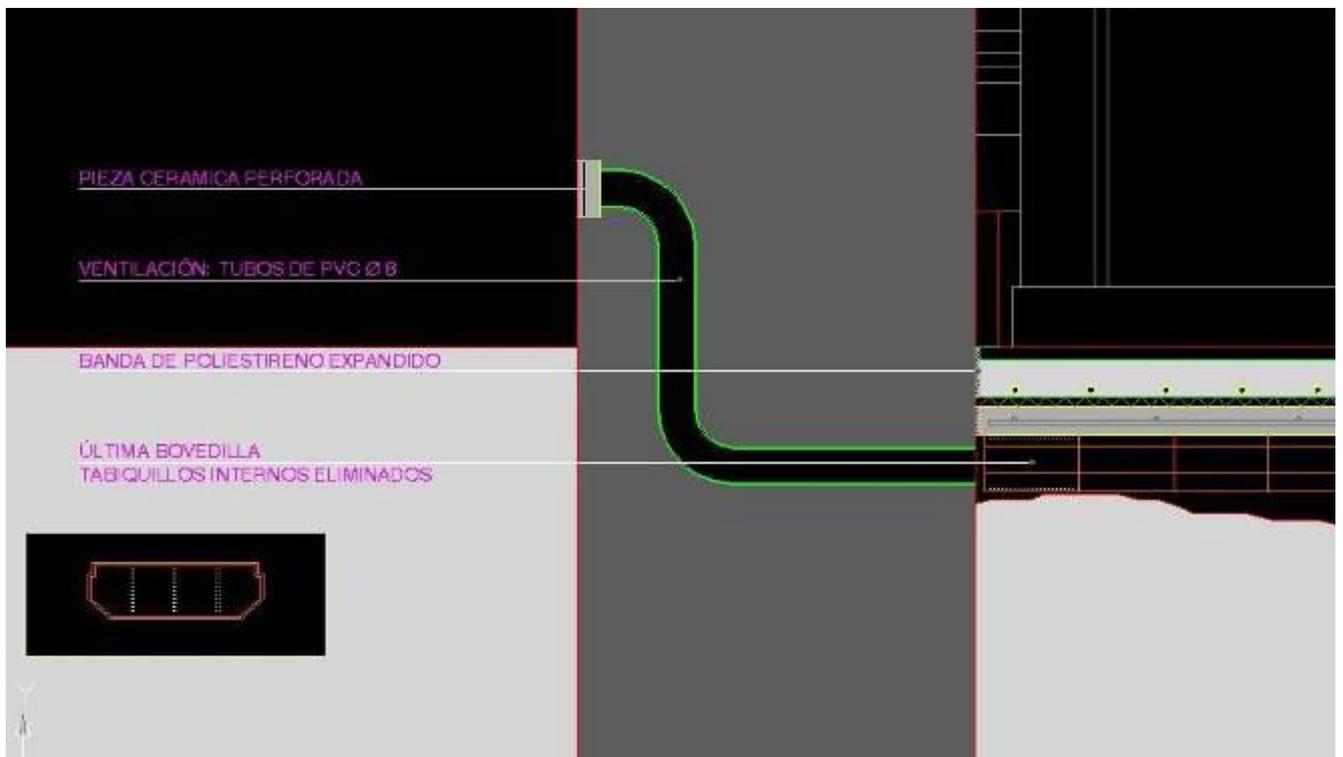
To give an idea of the clay pieces strength, they bore a heavy crane that came inside to paint the dome, once the paving was finished.

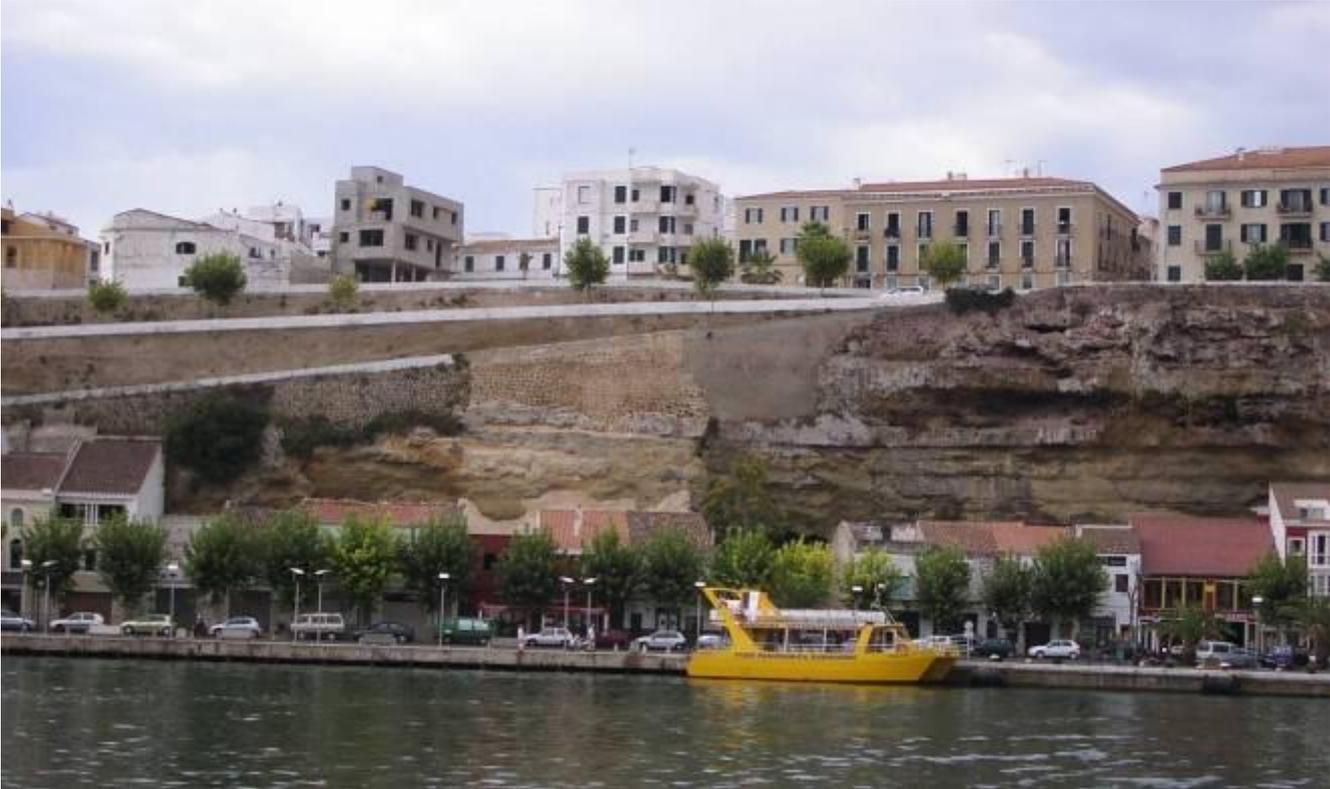
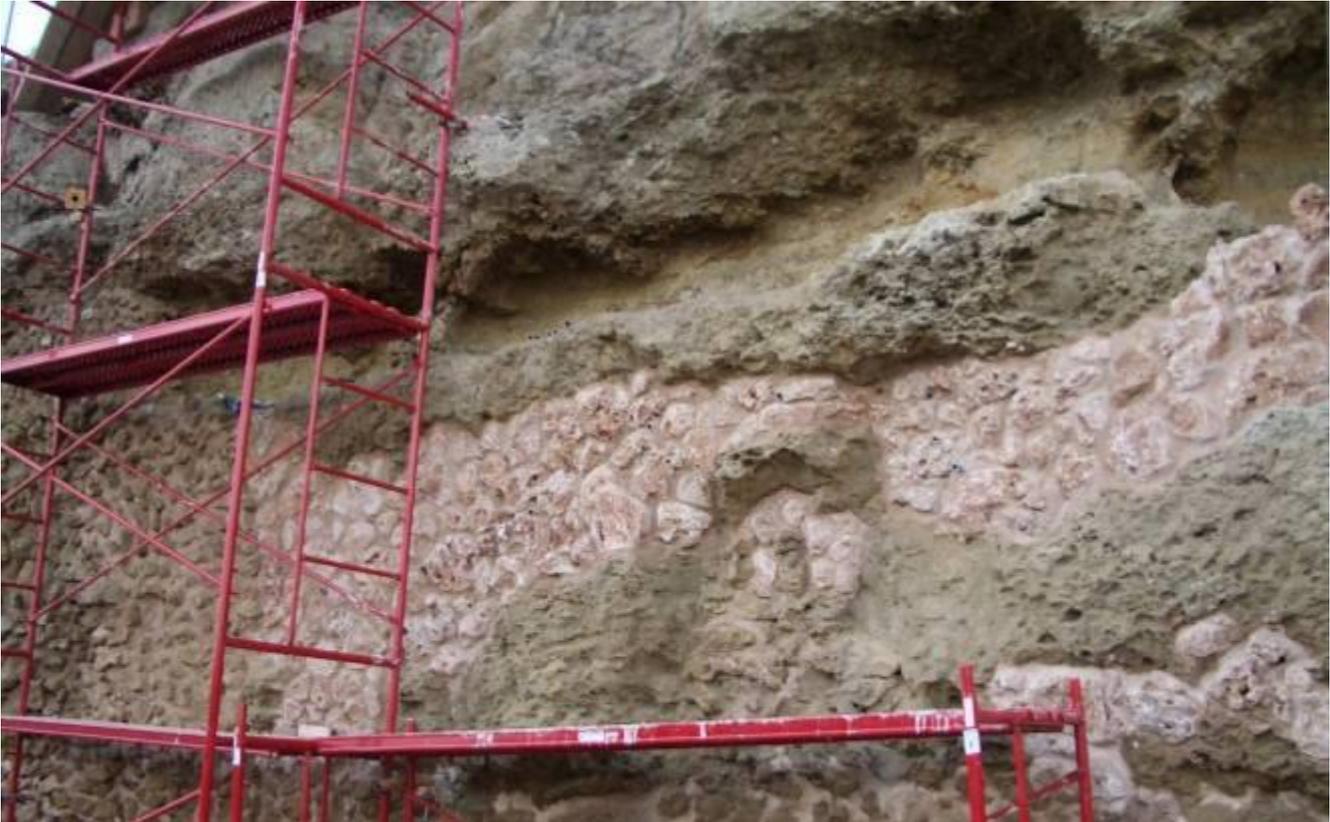
Mahón harbor cliffs, Menorca.
Stone masonry is “softer” than projecting damaged rocks, and is used to reinforce hollows and fragile faces of rock.

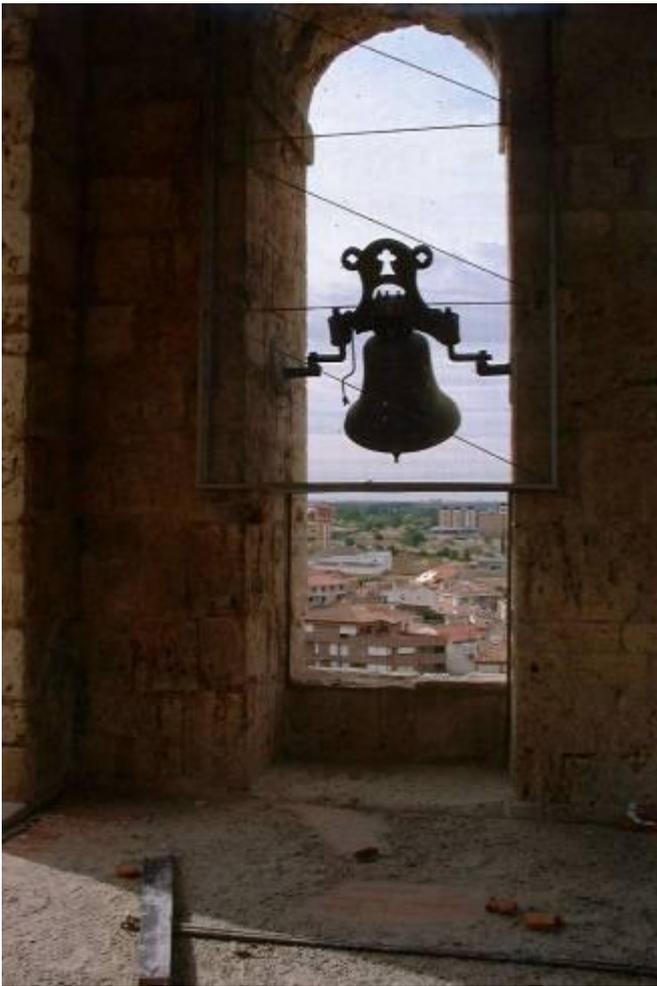
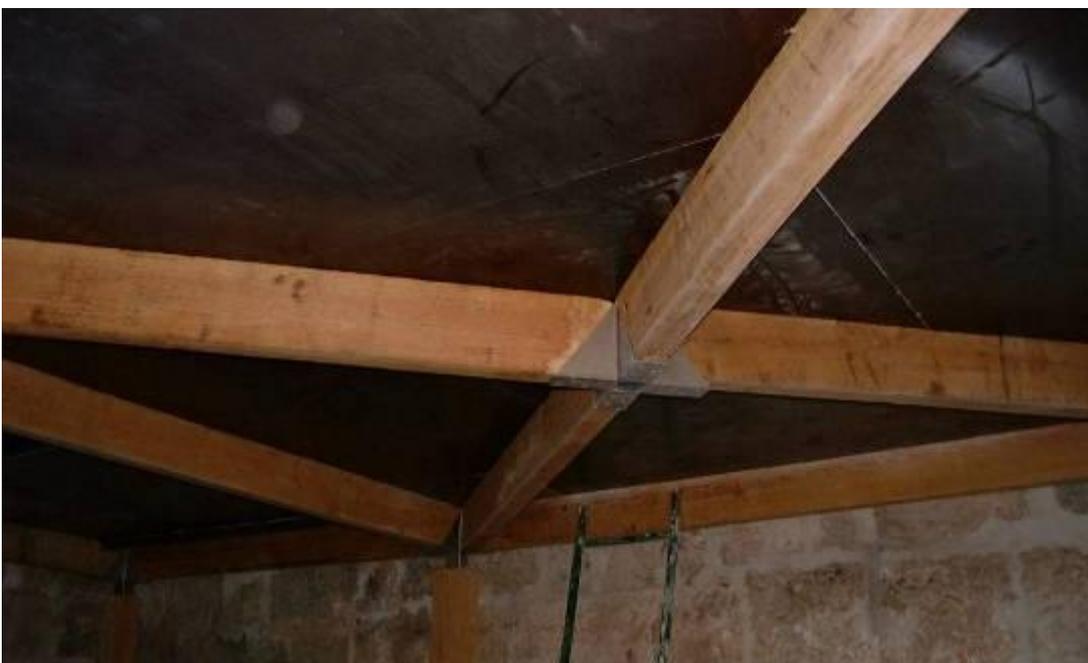
Bell tower framework. Church in Villamuriel del Cerrato, Palencia.

The structure is set up with timber ribs, reflecting the projection of the gothic vaults below, and fenolic plywood. Over this surface, only a brick without mortar paving.

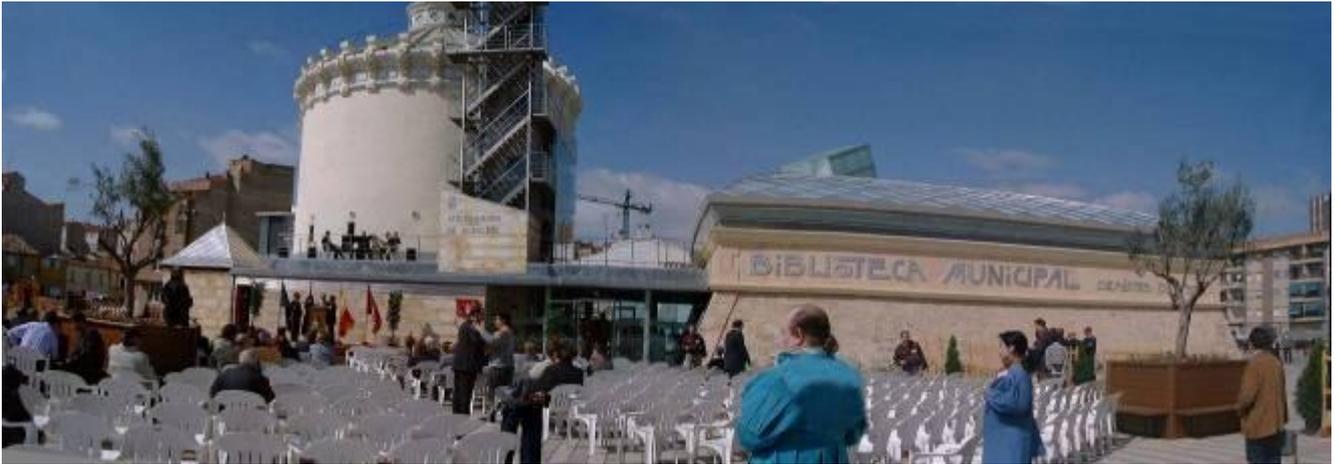
Central Library. Depósitos del Sol, Albacete.

Former water tanks were restored to become the Town Library and complementary areas.
For the large square tank, 20x20 m, now the reading room, we set up a structure of timber beams and fenolic plywood, with an external aluminium layer.

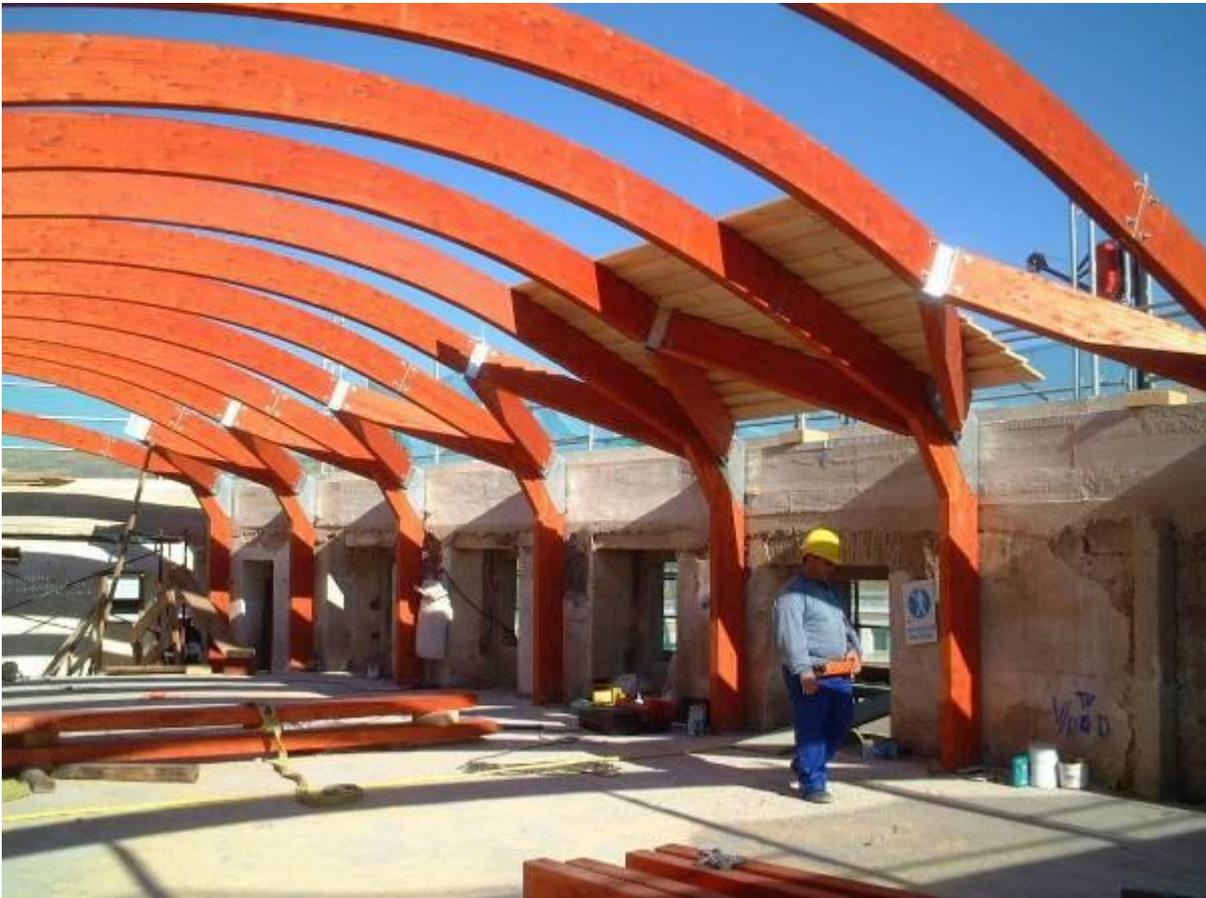
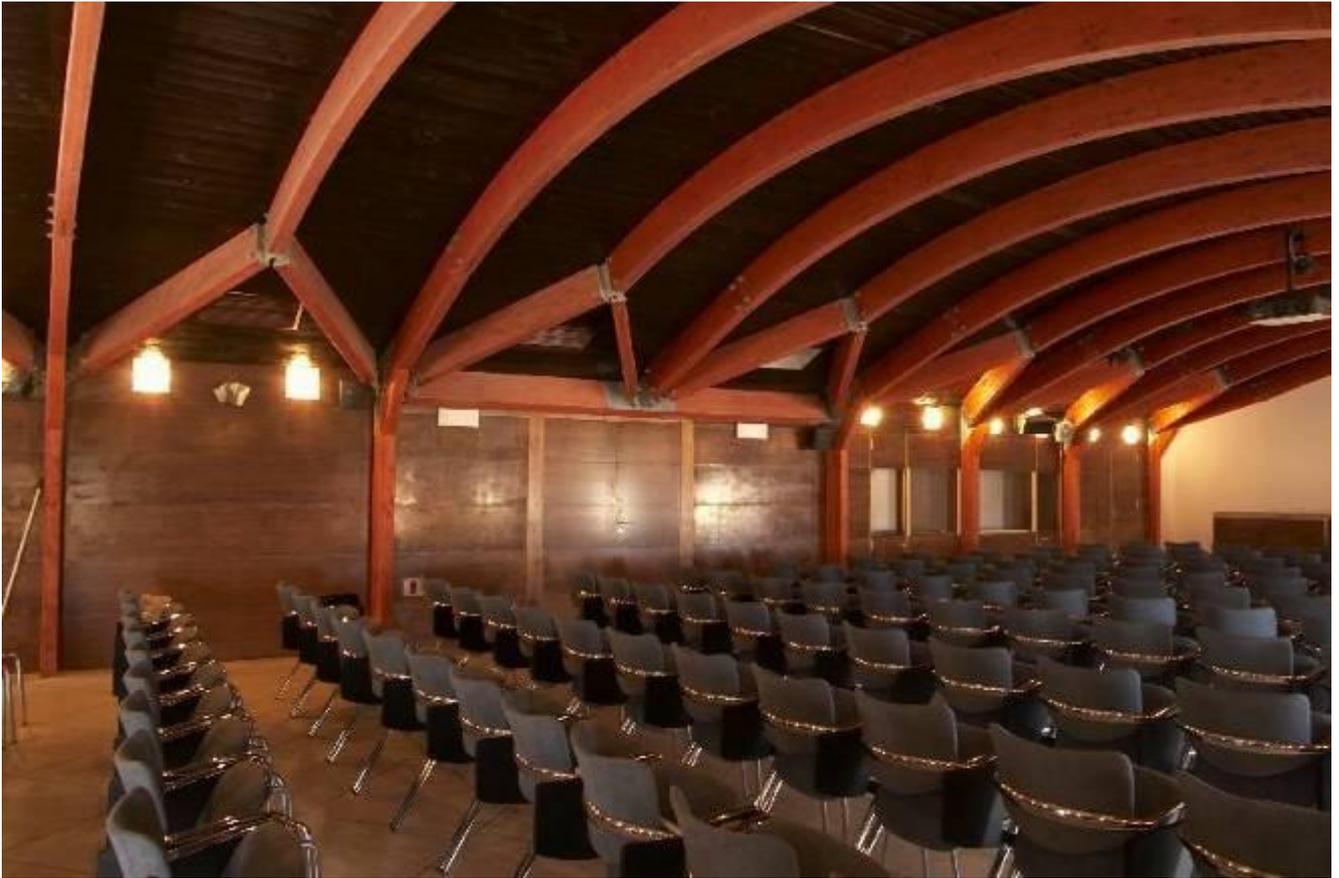
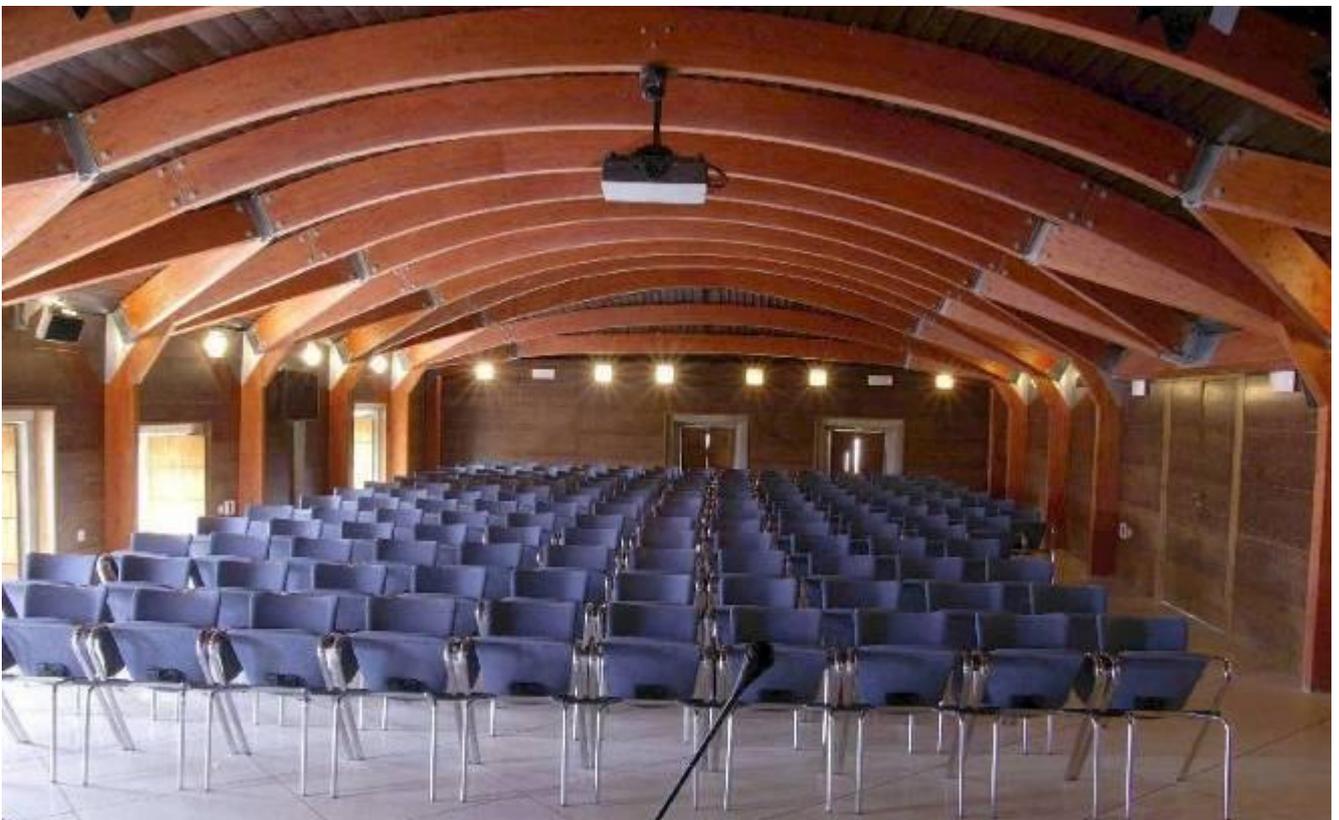
The glued laminated timber beams and the galleting of timber planks form the structure over the conference room, placed under the roof.

Besides its high aesthetic quality (the restoration achieved the Wood Building Design Award in Extremadura), timber showed its excellent features in acoustic conditioning.

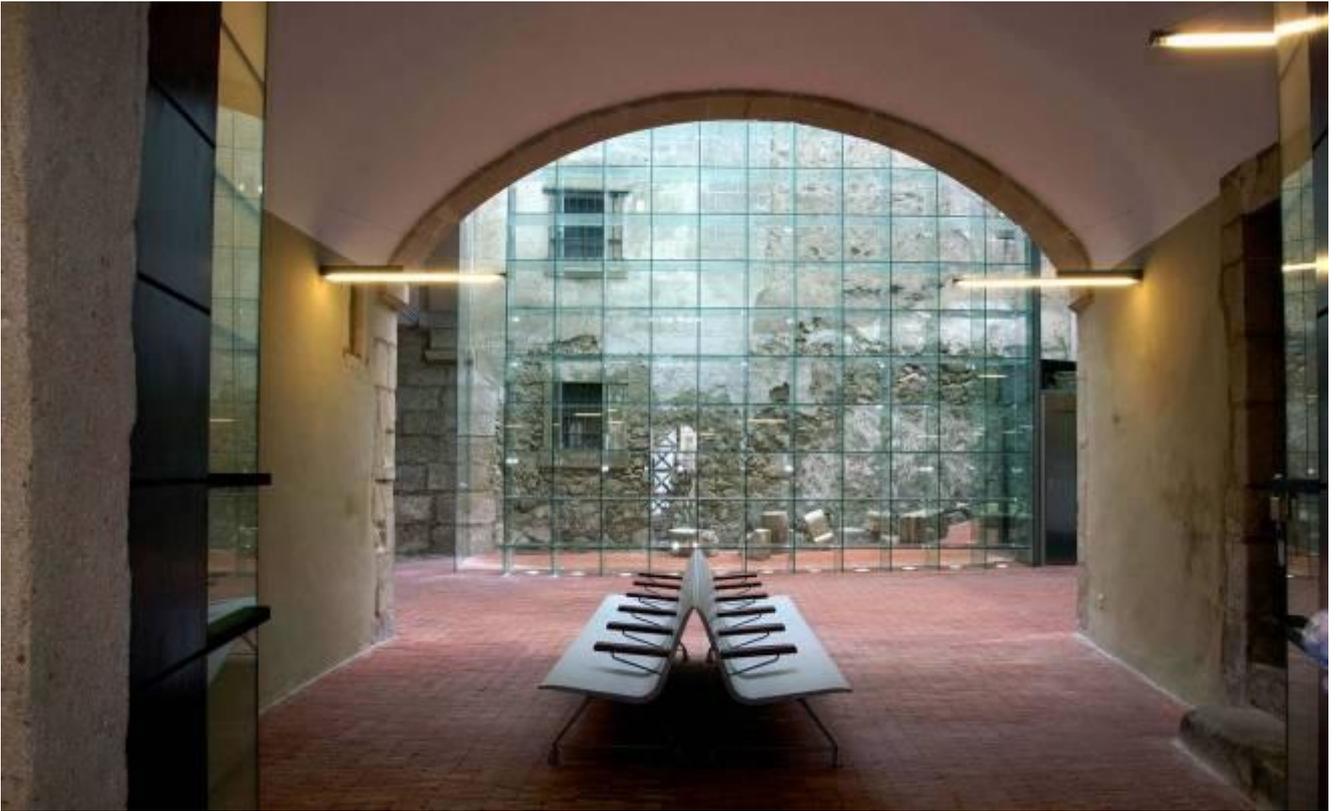
At the same Palace in Trujillo, glass layers stuck with silicone form a 13 metres high “structural wall” to close the courtyard, now used as lobby.

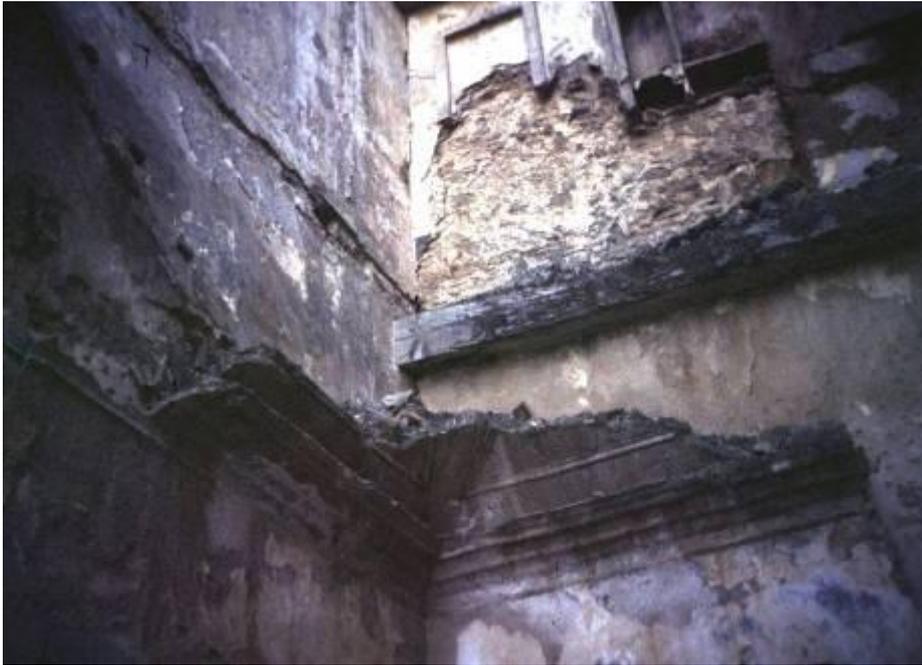
Sacristy in Sta. María de Requena Church (Valencia)

Even steel can sometimes be considered as the softer and most “conservative” material regarding the building remains.

The missing sacristy baroque vault is reproduced with black perforated plate, keeping even the smallest cornice or decorative remain in an “archaeological” way.

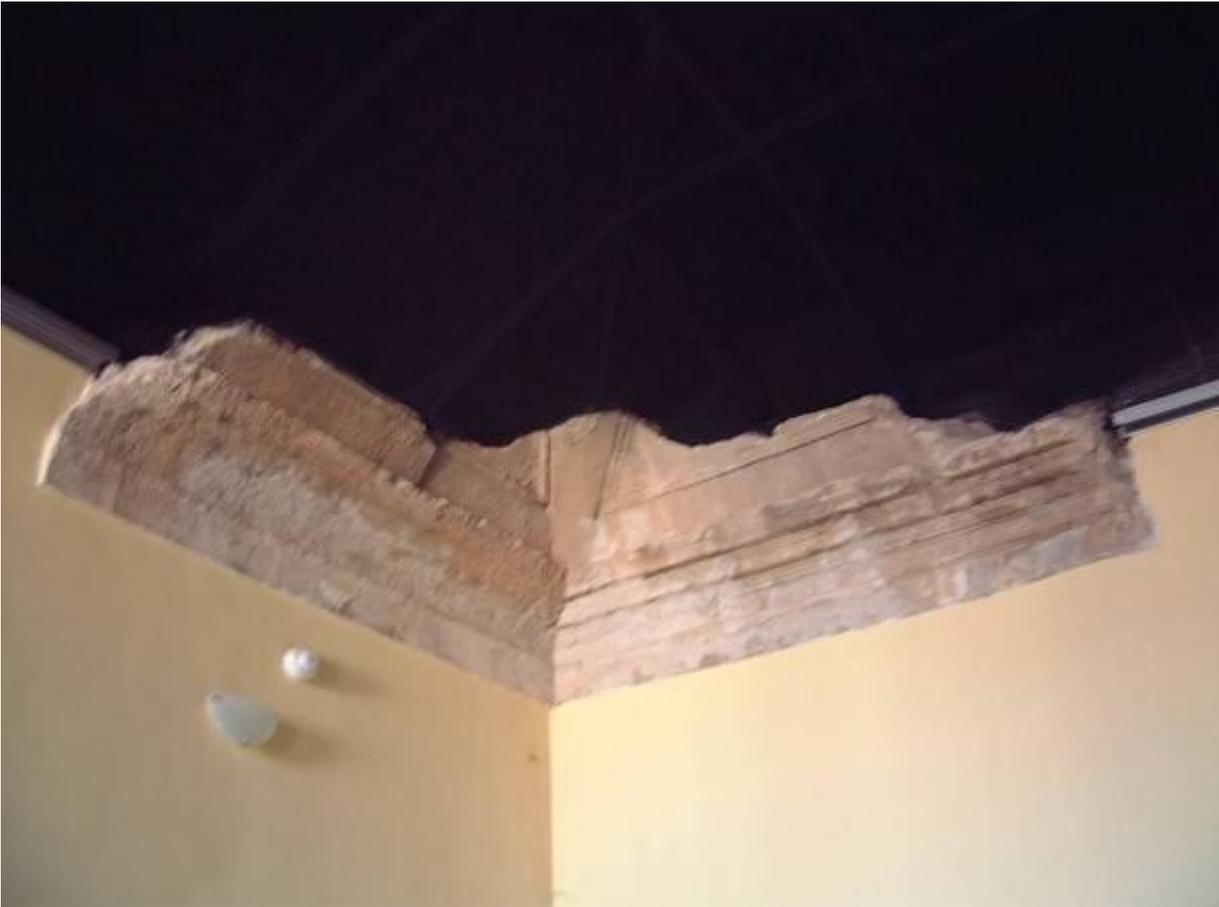
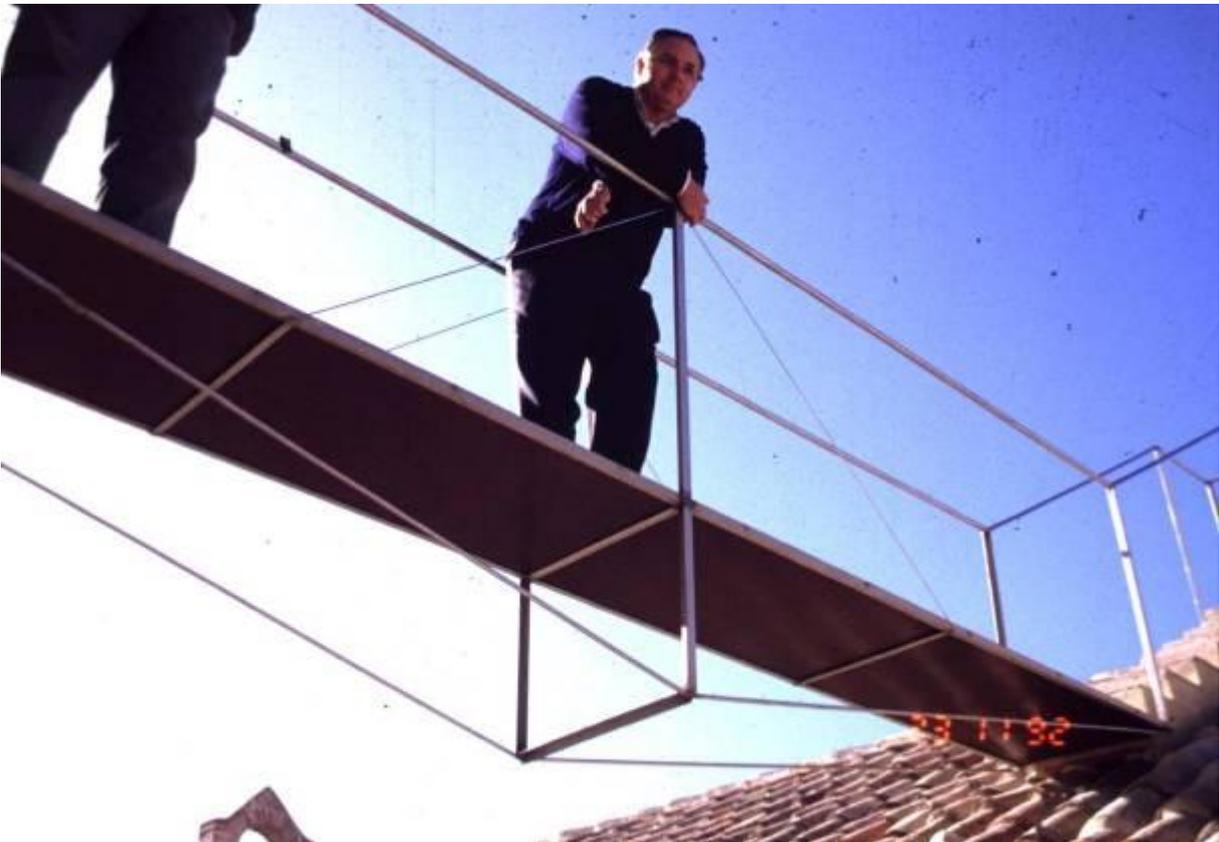
Stainless steel, together with fenolic plywood, is also useful to make minimum structures, as this bridge between the tower and the roof, to approach it for maintenance works.

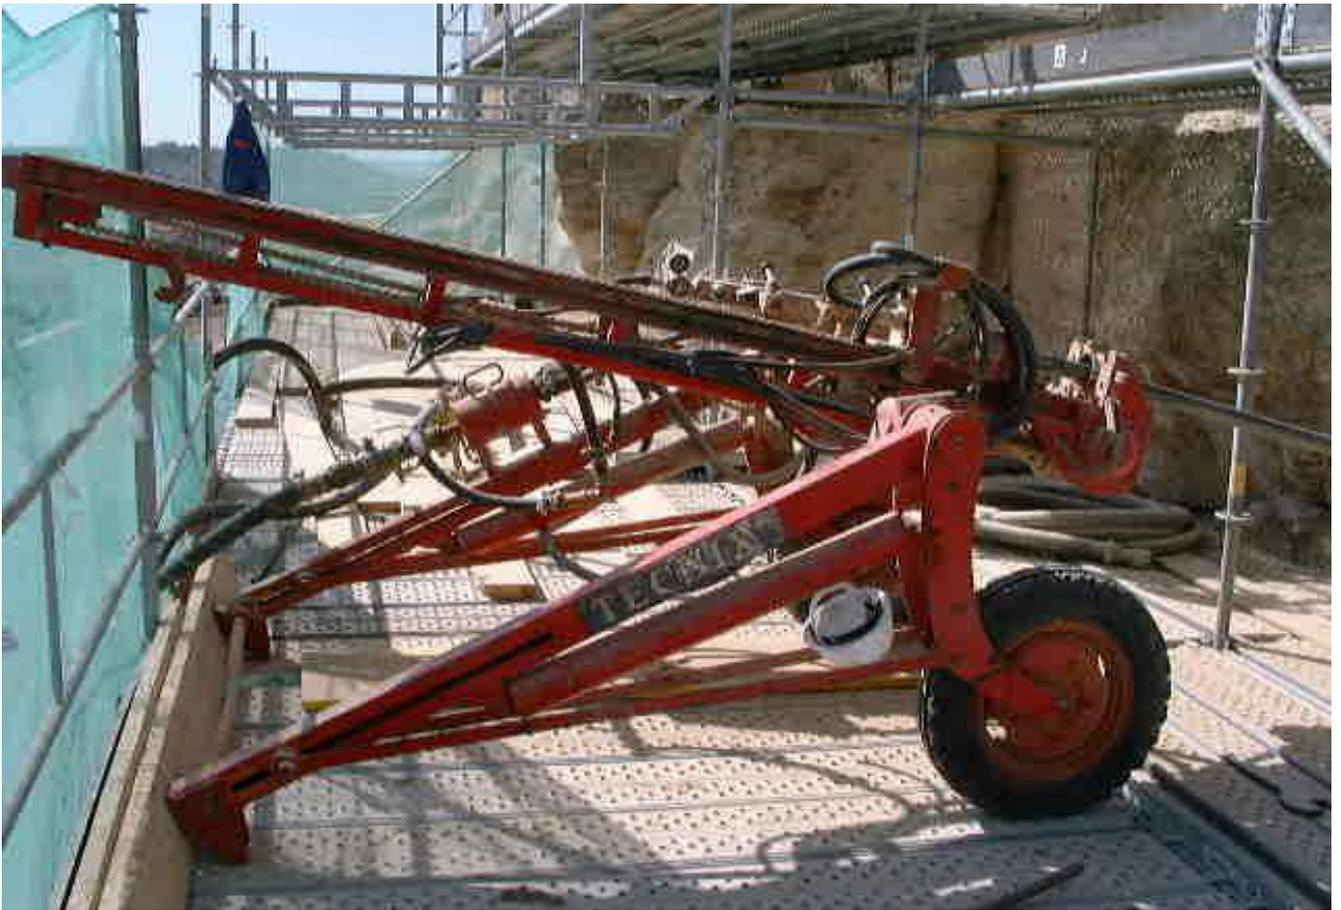
Sta. Marta Crags in Zamora

Glass fiber and carbon fiber (at Mahón cliffs) as invisible anchors for stony cliffs, fastening any possible sliding wedge.

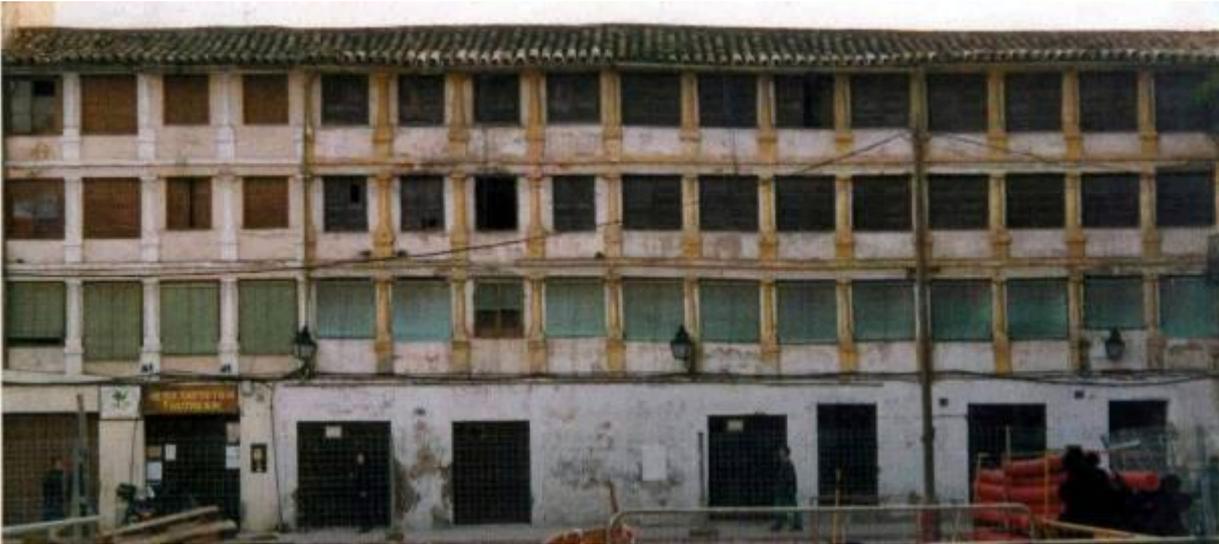
“Doña Jacinta” Building at Corredera Square, Córdoba

This building, the oldest in Córdoba Main Square, had been declared “hopeless”, as the material of the load bearing components, the facade columns, is a kind of limestone that breaks under a stress of 80 kg/cm². Furthermore, wood elements looked damaged, and were not well cared for.

The analysis showed a maximum stress to bear of 20 kg/cm², so the remaining strength is over the usual and standardized structural security rates.

This structure only needed to be “understood” to go on working.
